Airyholme Farm Buildings

John Crocker & Cath Small

2012

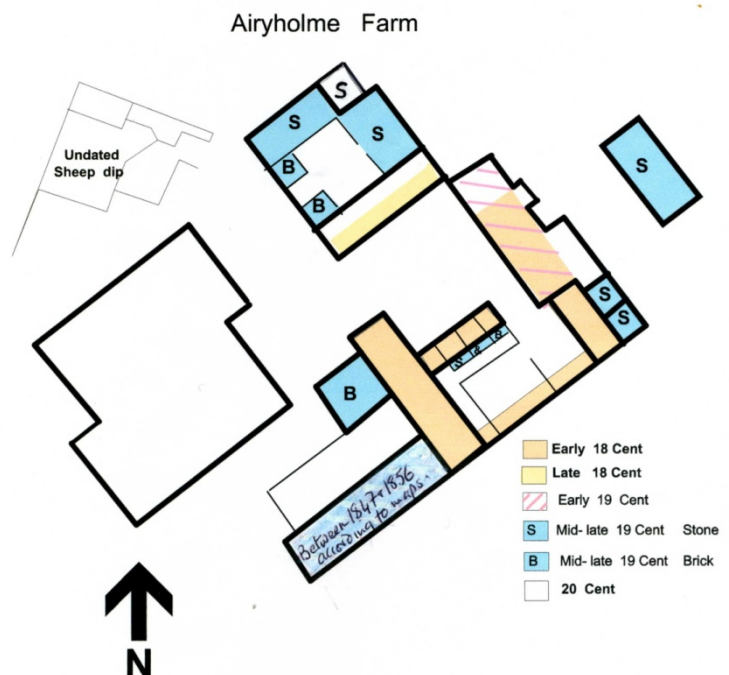
The farmstead layout

As seen in the plan the farm buildings date from the early 1700's to the present day. There is evidence of alterations and additions as demanded by changes in agriculture over 300 years, both nationally and locally.

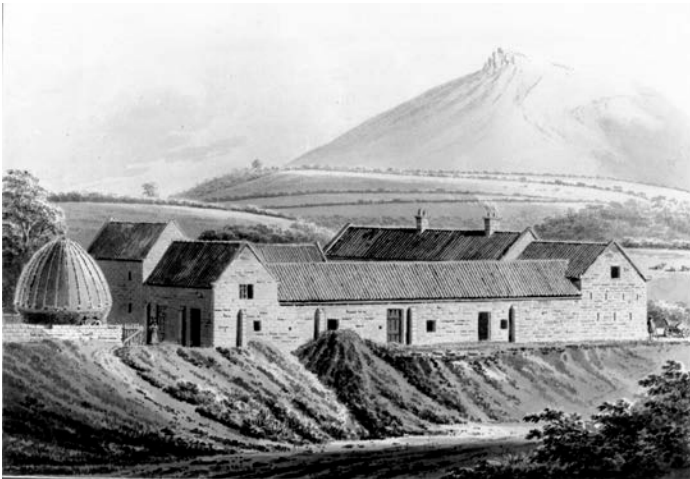
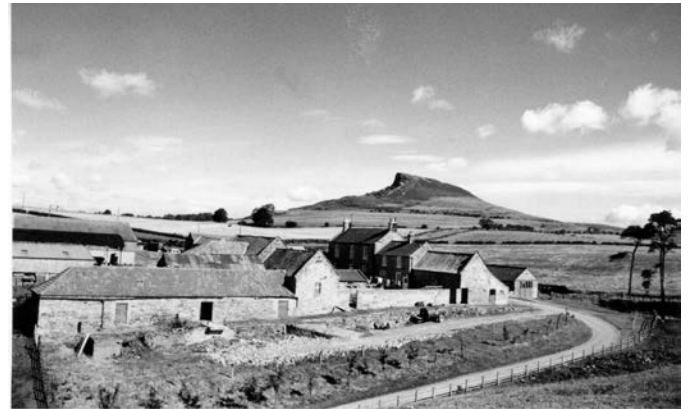
The basic layout has changed very little over its lifetime. A comparison of the pictures below taken over two hundred years apart shows this. The additions and alterations can be seen in the changes to the dwelling house and the inclusion of buildings made with modern materials.

The illustration on the left is of the farm as it was when George Cuit sketched it around 1790. He made several sketches around Great Ayton which are accurate in context and perspective leading to the assumption that his drawing of the farm is accurate..

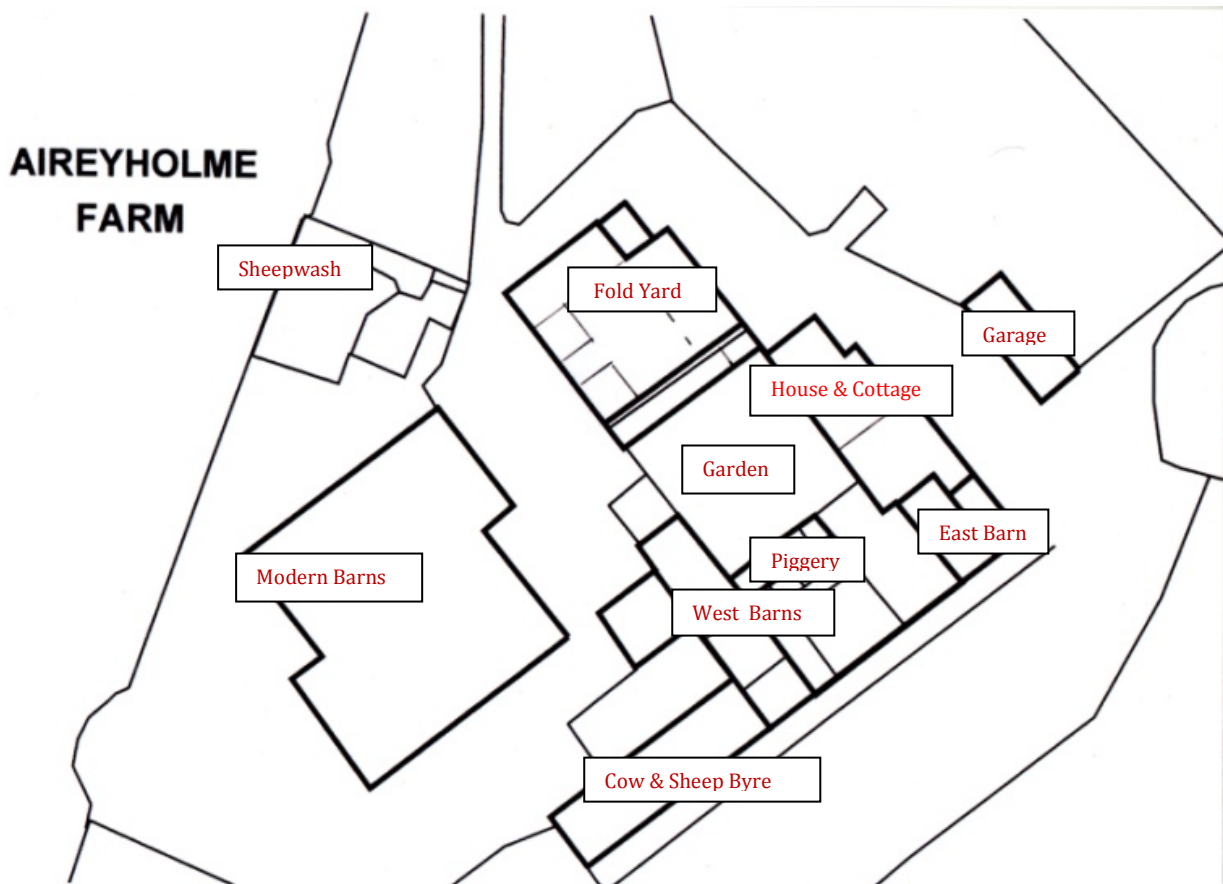
Arial view of farmstead taken after the end of the Second World

- a. Farmhouse**
- b. Cottage**
- c. East Barn**
- d. West Barns**
- e. Sheep Byre**
- f. Old Implement Shed (replaced by modern)**
- g. Wheelhouse**
- h. Old Hay Barn (replaced by modern)**
- i. Foldyard complex**

The hay barn seen in the arial photo has been replaced two large animal and general purpose barns.

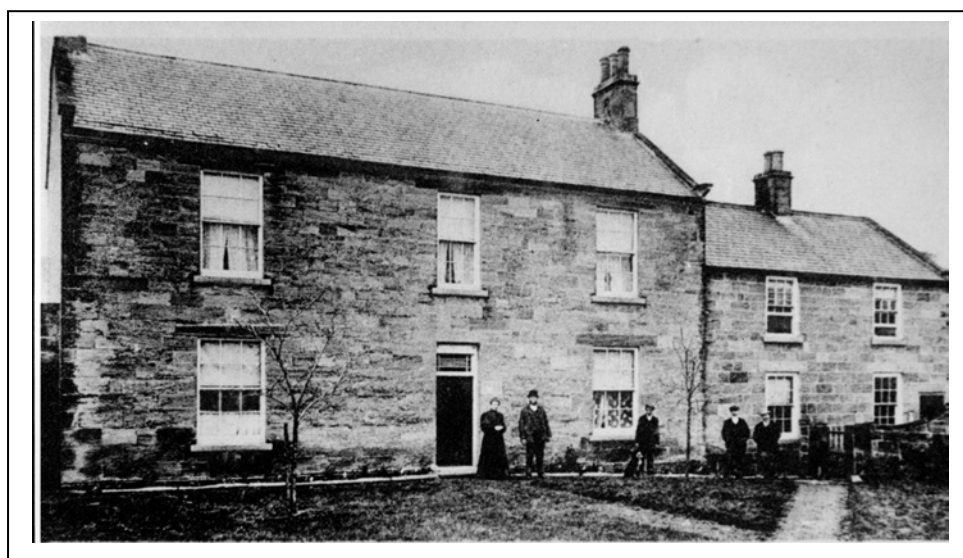
The photograph shows the house and cottage taken from the garden about 1900. Notice the lack of symmetry on the front of the house. It is possible that the house was enlarged at some time.

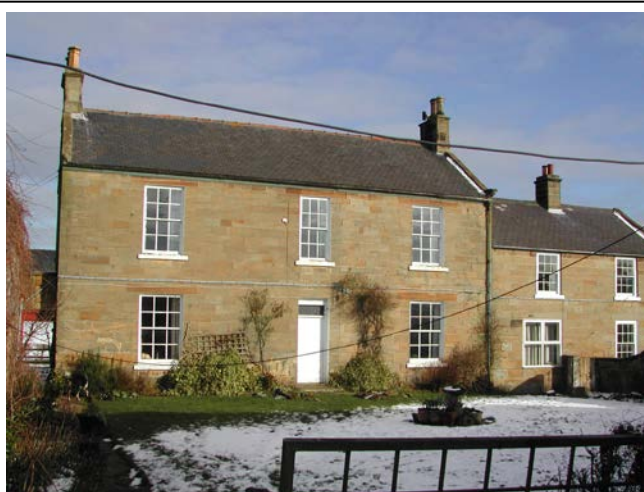
The present day view shows that the house from the front has not changed in over one hundred years. The cottage is also unchanged except for the left downstairs window having been replaced at some time by a larger one

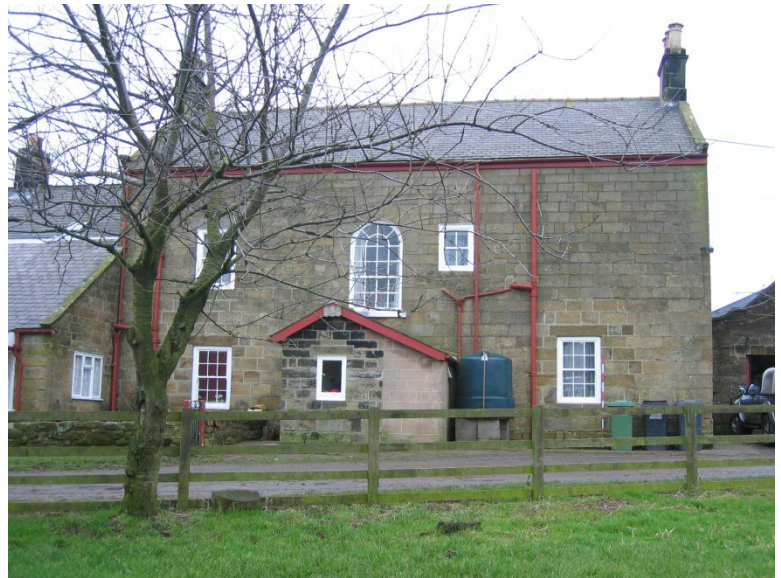
The rear of the building shows more alterations than the front. There has been an entrance porch added and work done to the north downstairs window. It also shows the same lack of proportion as the front, again suggesting an extension to north end of the house.

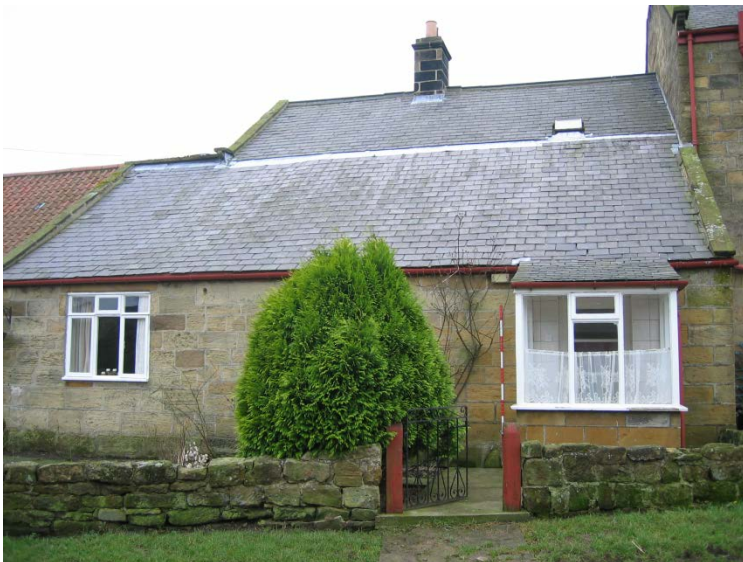
The rear of the cottage shows a very different picture. It shows a 20th century addition in the form of a lean to extending the full length of the cottage, built of stone blocks and having modern windows and a porched entrance. Behind the shrub there is another small window.

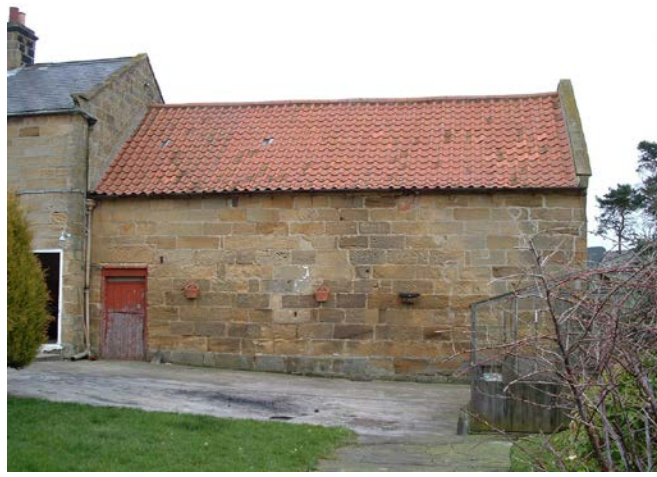
The East Barn seen from the west adjoins the cottage. The paved and grass is the small fold area, possibly the original workyard of the farm. It is no longer used for this purpose

This building – one of the original shown adjoining the south end of the farmhouse in Cuit's sketch is probably the earliest datable on the farmstead.

The roof trusses date from the 1720 -1740's plus the earth mortar in the east wall is indicative of the first half of the 18th century or even earlier.

The south end of the barn has an entrance plus a loading door and ventilation slits (filled in). These along with the opposing doors at the north end next to the cottage point to its use for storage and being used as a threshing barn at some time in the past.

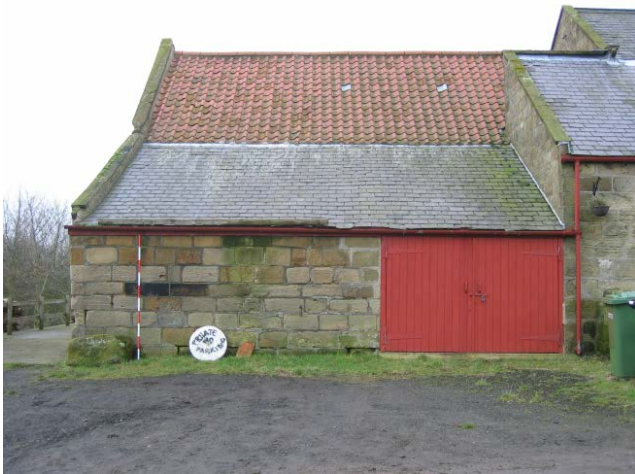
The barn viewed from the other side shows a lean to attachment which was added sometime between 1856 and 1895.

Though now used for storage, it was used as stabling. One use of the stable was to house the horse used to pull the ambulance for the Roseberry ironstone mine. There was an entrance to the mine on the land now farmed.

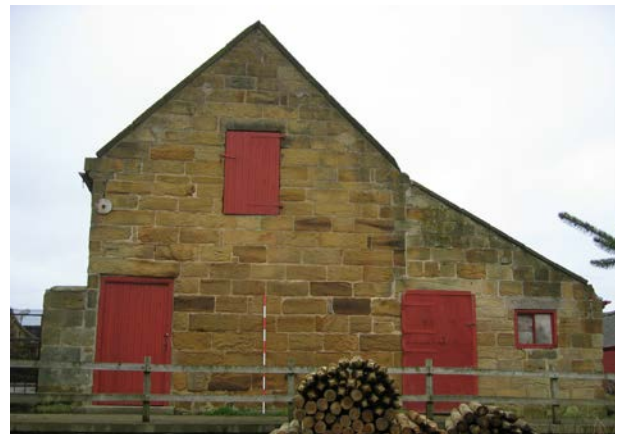
The gable end of the barn from the south shows the entrance door and the top loading door through which sheaves or hay etc could have been off loaded from the hay carts. One obvious change of use was it being turned into a five stabled barn sometime before 1910 as recorded in the survey of that date. The end of the lean to can also be seen with its door and only window.

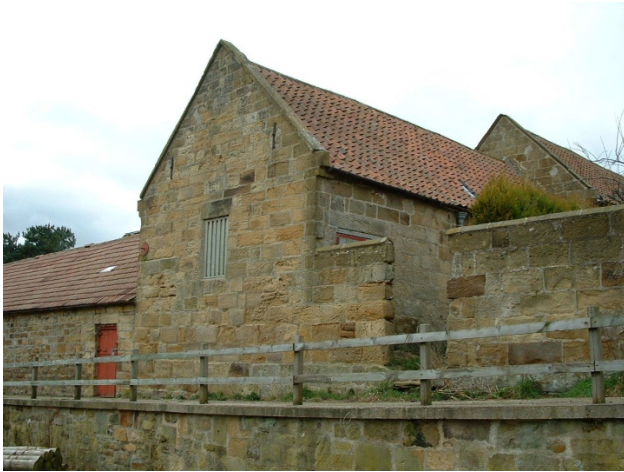
The West Barn Complex comprises of, as seen in the photo, a sheep byre to the left adjoining a small barn also used for animals and a larger barn behind. The larger barn has a now defunct wheelhouse built onto its west side. The wall running to the right runs to end of the east barn and supported a number of small work units for coal, laundry etc. These were demolished in the 1980's due to land slippage and the wall rebuilt using the original stone.

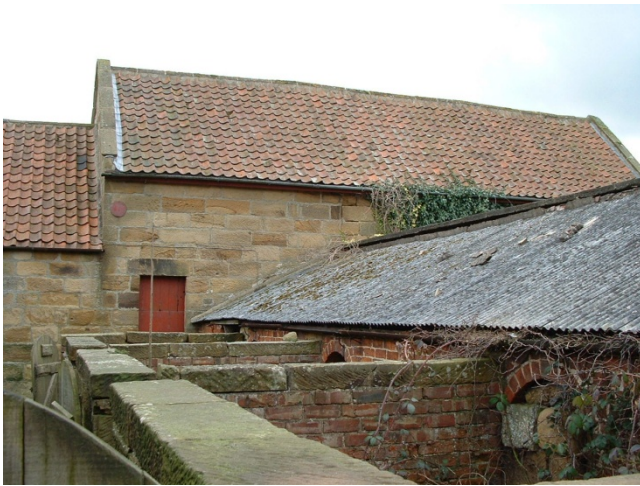
The west barn seen from over the piggeries. Externally both barns fit with mid C18 style but have no precise dating features. The roof trusses which are later with hanging king posts, could be anywhere between 1780 and 1900. Walls are one block thick and buttressed internally. The earliest known single block wall in the area is dated 1740.

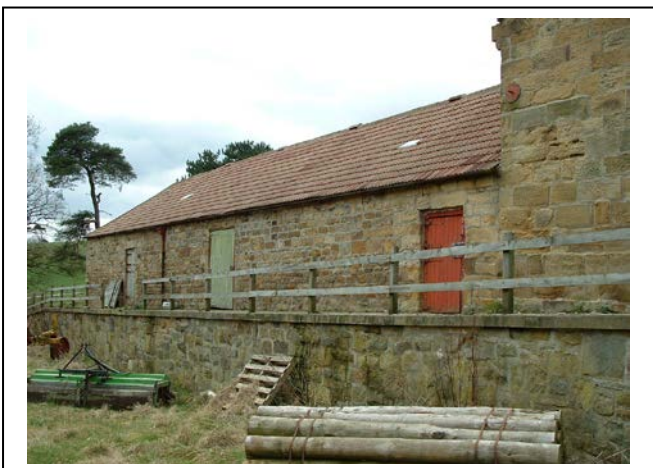
The sheep byre was constructed sometime between 1847 and 1856 and has not changed since then and the present day.

Nor does its use for animals seemed to have altered.

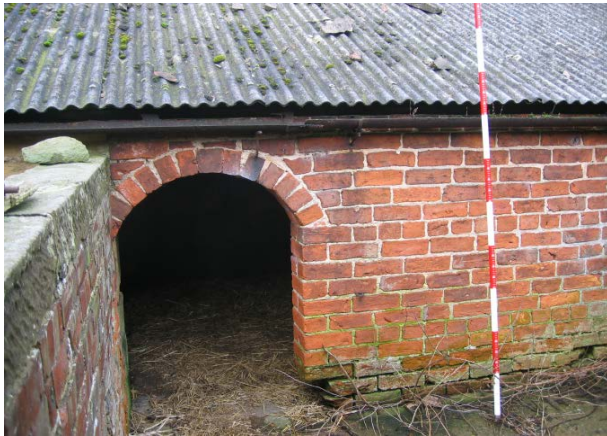
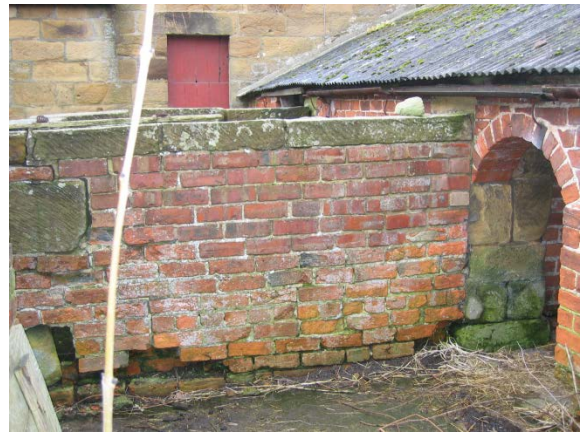
The Piggeries These consist of three pigsties each with an enclosed exercise area surrounded by a six foot wall. The walls are pierced with slots for pouring in the swill. The structure shows signs of much rebuilding of brick on stone, the shape however has remained unchanged since it was first depicted in 1856. They show signs of having not been used for a number of years.

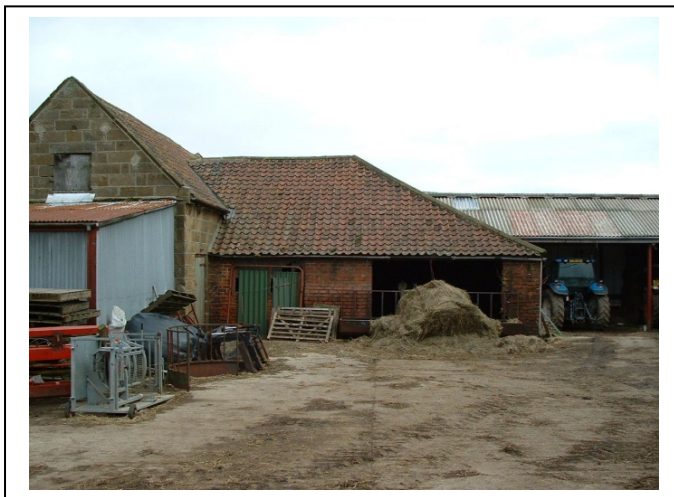
The Wheelhouse is built onto the west barn, possibly onto a threshing floor. Constructed with brick sometime between 1874 and 1856.

When its use as a horse operated wheelhouse was no longer required it seems to have been altered using modern bricks to accommodate animals.

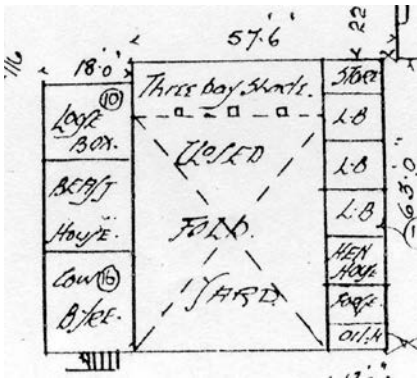
The diagram from the 1910 survey gives an idea of the development. The cow byre and beast house to the left (the loose box was a later addition) called the "Old Granary" by the present Mr. & Mrs. Phalps, probably dates from the end of the 1700's. The upper storey being added later. Walls roughly finished squared stone. The ceiling over the byres seems to have two layers of boards, the upper, the granary floor being twice the width of the lower. Possibly to keep the smells and sweat away from the grain! The loose boxes came next followed by the northern bay sheds.

It seems to have started as a single line of animal housing. Later an upper storey was added as a granary. A parallel building for animals was added to the south with another joining them together at the east end. This formed a three sided foldyard. In time the open side was closed by a brick structure and then followed by roofing over of the open centre of the yard.

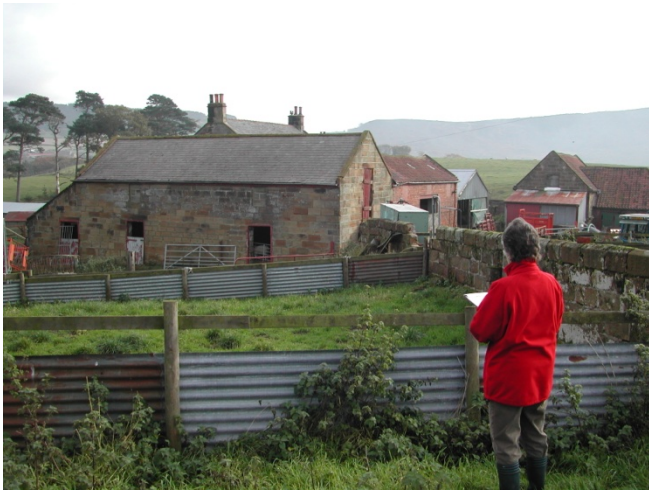
The 'Old Granary'. The entrance to the upper floor can be seen on the end. The two doors have others opposite allowing access into the foldyard. The loosebox is seen as leanto on the left.

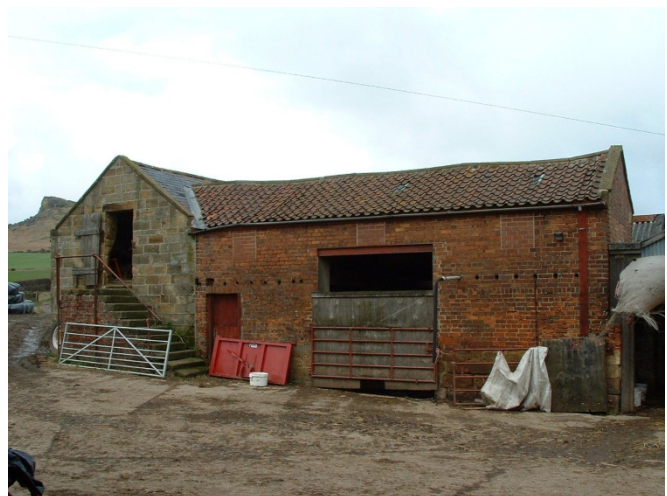
The front of the foldyard, the original entrance, seems to have been closed of f with a sandstone wall of which four courses remain sometime between 1856 & 1894. Post 1910 it becomes a two storey building with a pantile roof. The large entrance is flanked by a compartment on either side each with an upper storey with windows, now blocked off. The entrance to the Old Granary can be seen to the left

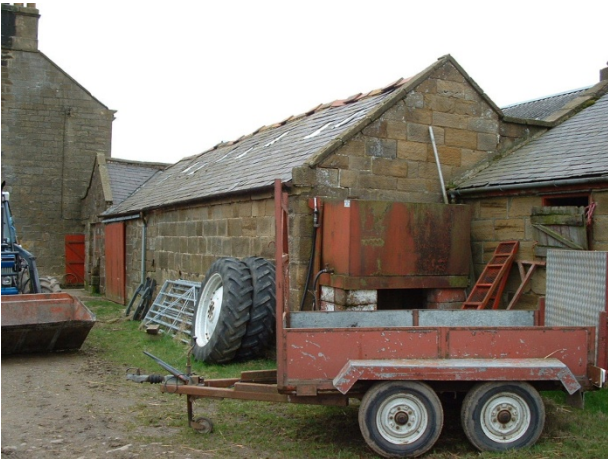
The rear of the yard, the building called the three bay sheds on the 1910 survey.

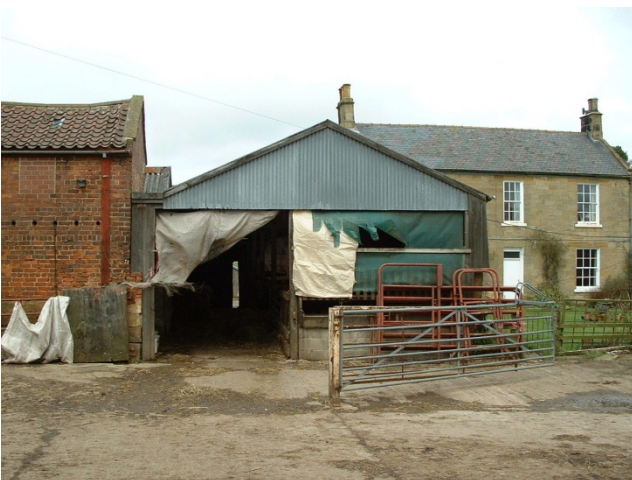
The present end view of south side of the foldyard . Originally described as a line of loose boxes in 1910. It retained its long narrow rectangular shape and was a separate entity until the 1970's, when it was roofed over to cover the space between it and the foldyard. Fabric etc indicate an early 18C date.

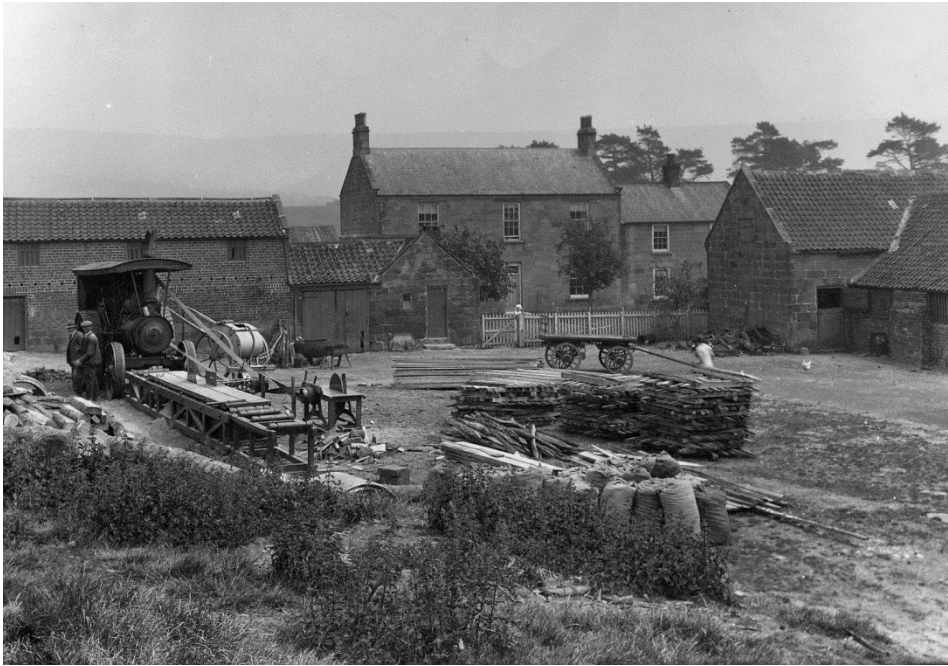
In this photo, taken about 1929, the end of loose box building can be seen as a separate building before being roofed over to make it one with foldyard in the 1970's. The adjoining double doored entrance led into the foldyard .
