BROOKSIDE FARM, LITTLE AYTON

A cross-passage farmhouse of historical importance

Brookside Farm was surveyed by members of the Great Ayton Community Archaeology Project (Cath Small, Ken Taylor, Bob de Wardt, Dave Taylor and Ian Pearce) in May 2009.

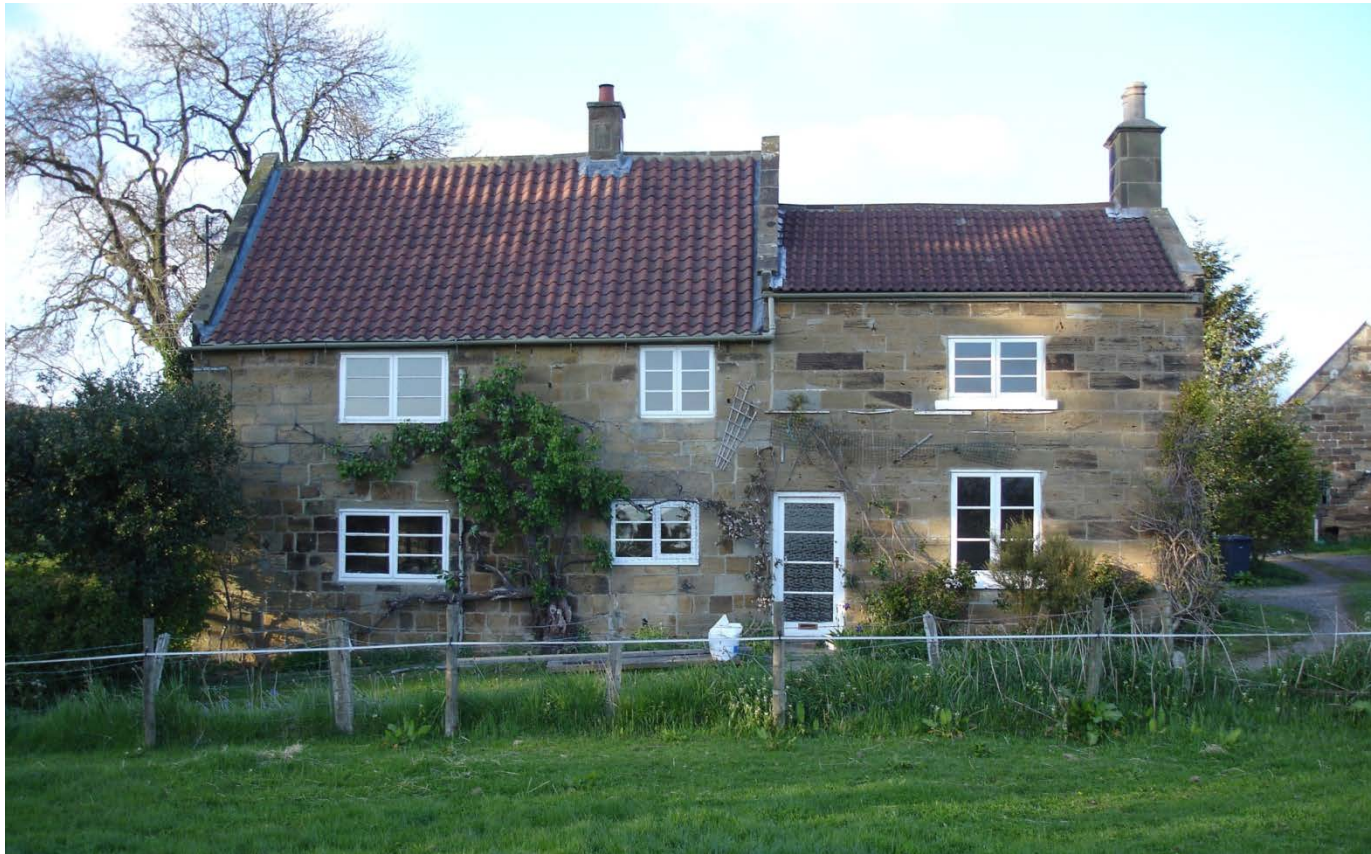
Some of the original features have been lost, notably the original stone mullioned windows. Older villagers remember them still being in place, but now there are only modern wood-framed windows, and an ill-assortment at that. Because the farm is owned by an estate, and is rented out, expenditure on the building has been kept to a minimum. This has preserved other features which may otherwise have been swept away in the name of 'home improvements'.

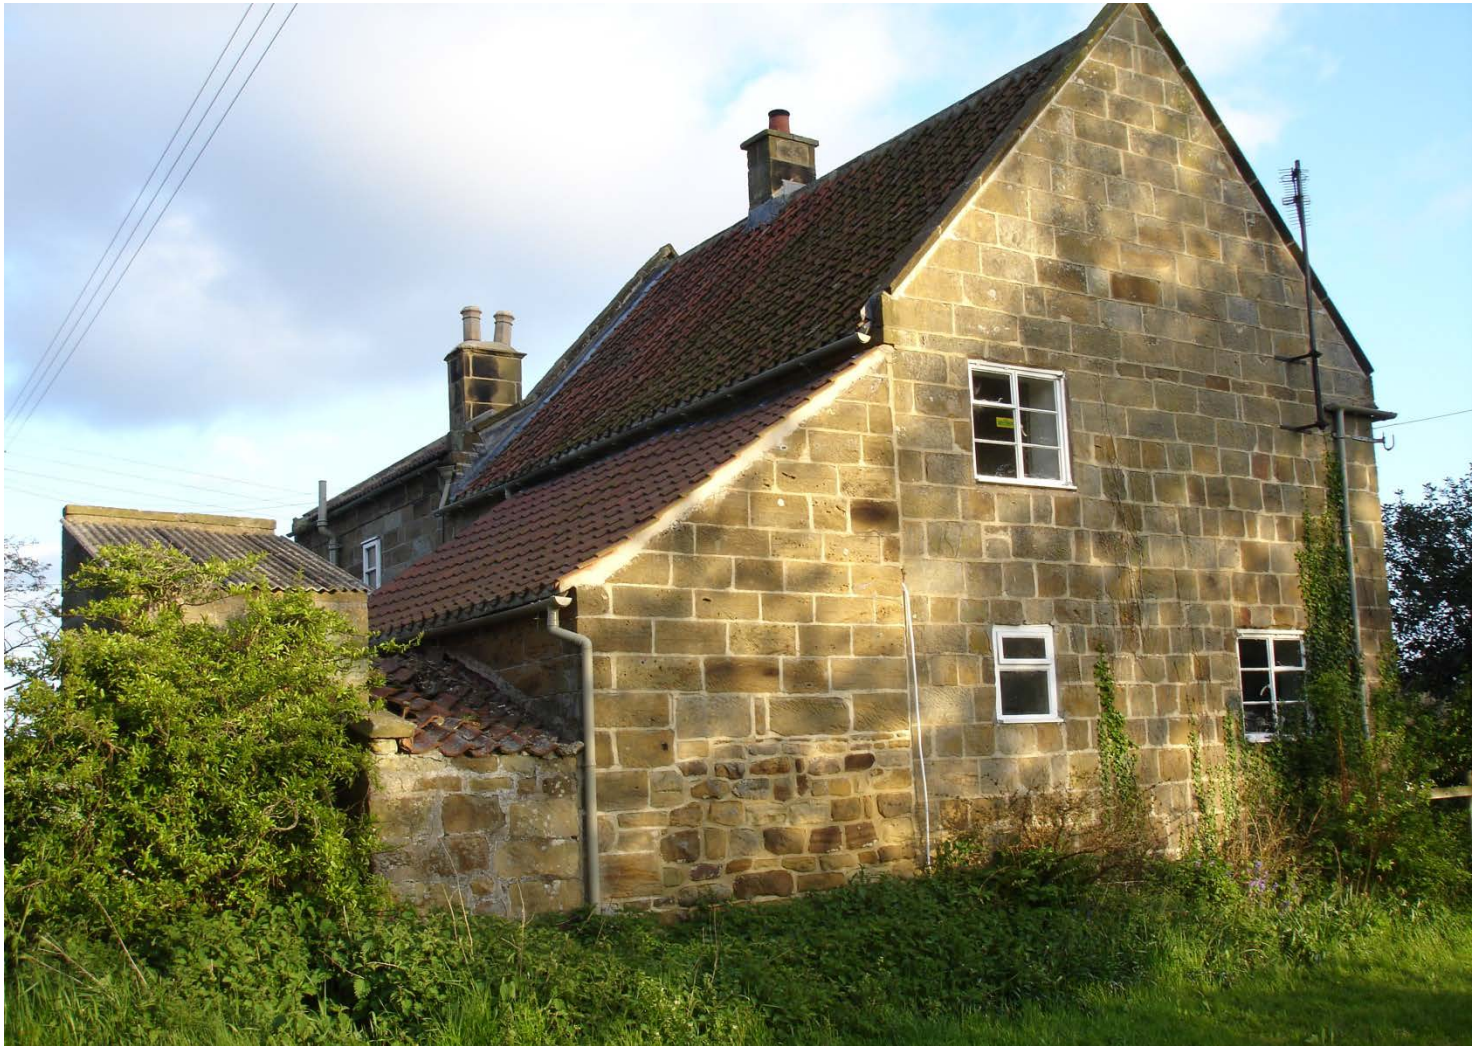
The north-west end wall. A large extension has been built butting up to the rear wall. The old earth-closet (with a corrugated iron roof) still stands, and the space between it and the extension has been roofed over.

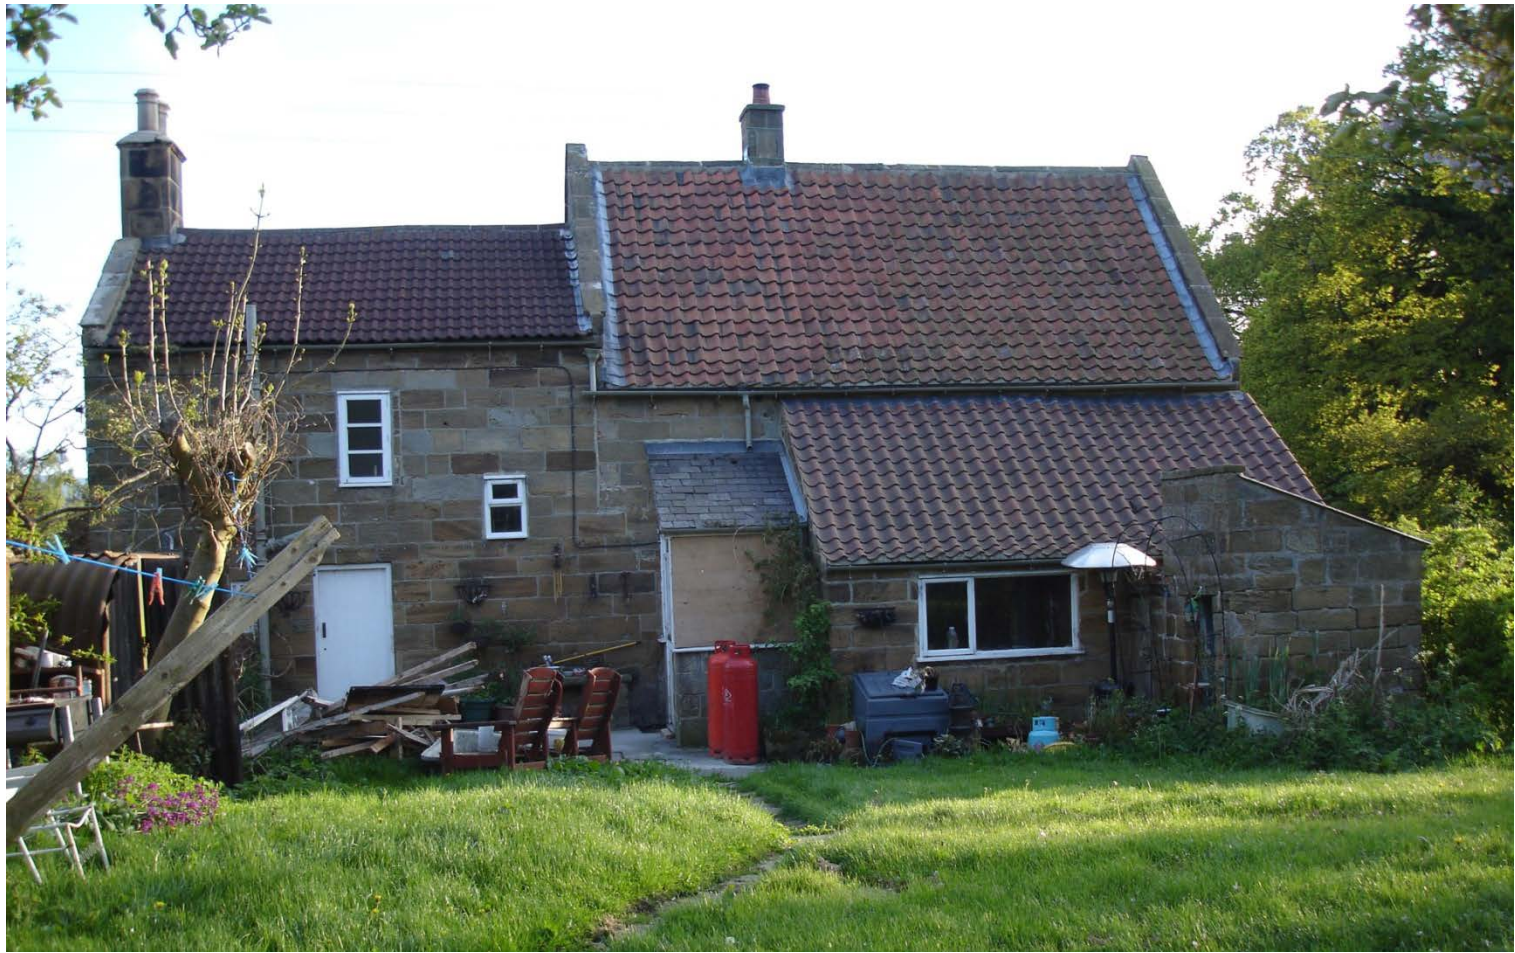
The rear of the house, showing the extension and a later, small porch. The old byre-end, to the left, has been virtually rebuilt and given a handsome chimney with two flues. The small window between the white door and the red gas cylinders, gives light to the staircase. The staircase was added when the byre-end was rebuilt, and replaced what was virtually a ladder leading up from the fore-house.

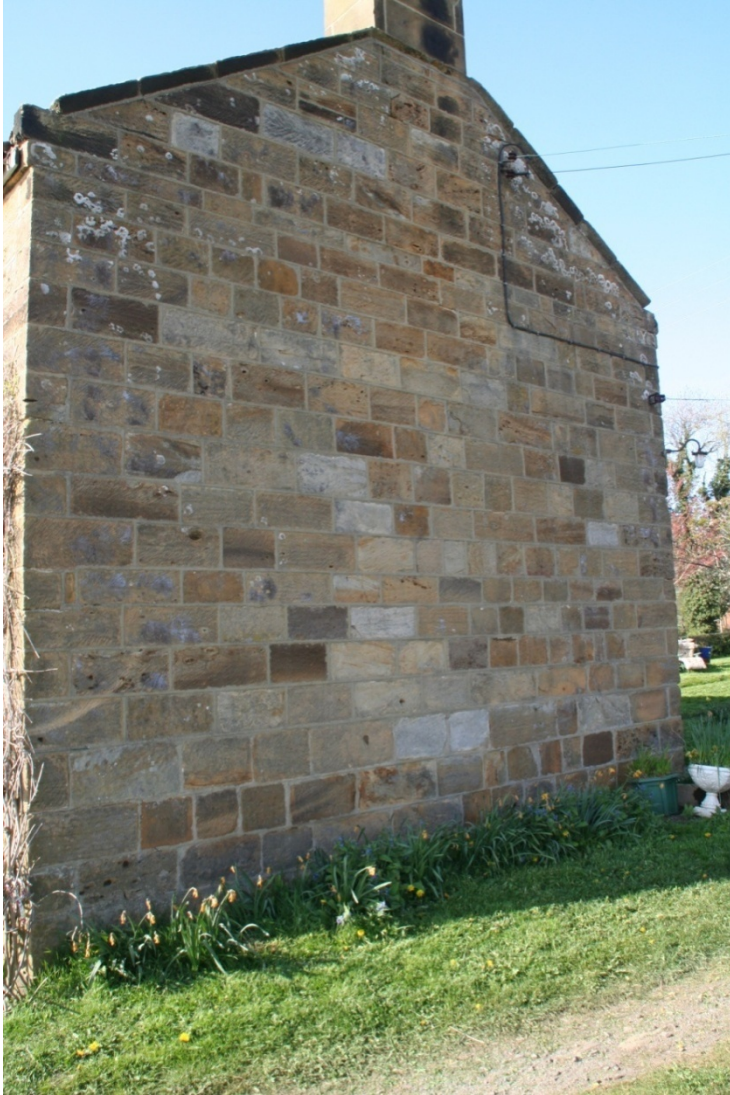
The south-east end wall. This is the rebuilt byre-end of the building, and the stone-work appears to be of a better quality than the rest of the building. However it is still a very plain building, with very simple kneeler stones. These are the horizontal stones, at the top corners of the wall, which support the coping stones coming down the gable end from the chimney.

The pitch of the roof at the byre-end is shallower than the main part of the house, resulting in a lower ridge. This suggests it was built for slates, which became available with the arrival of the railway in 1864. The main roof, with its 90° pitch, would have been designed for clay pantiles. An earlier, thatched roof would have required an even steeper angle of pitch.

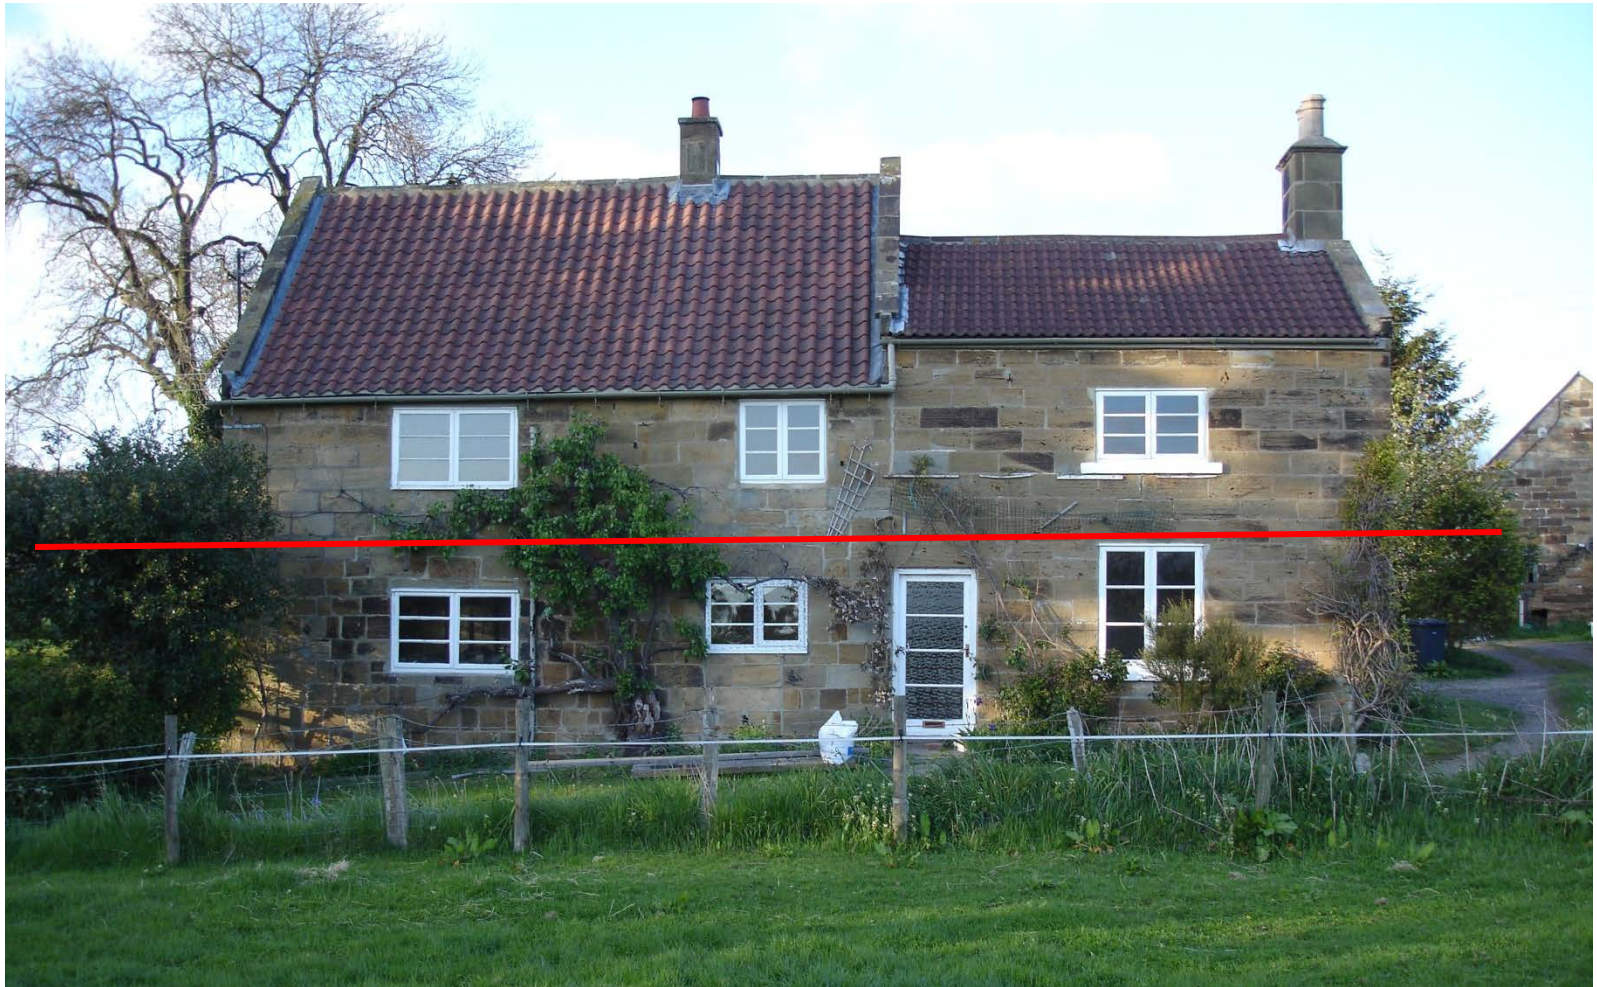
What Brookside Farm may have looked like when originally built

The original farmhouse would only have a ground floor. The roof may have been supported by timber 'crucks' (massive slightly-curved timbers arranged in an inverted V shape and built into the gable walls). It may have been roofed with heather thatch. Original construction possibly in the early 1700s.

Space in eaves reached by
ladder

Living space

Cross-passage with massive
stone lintel

Byre for animals

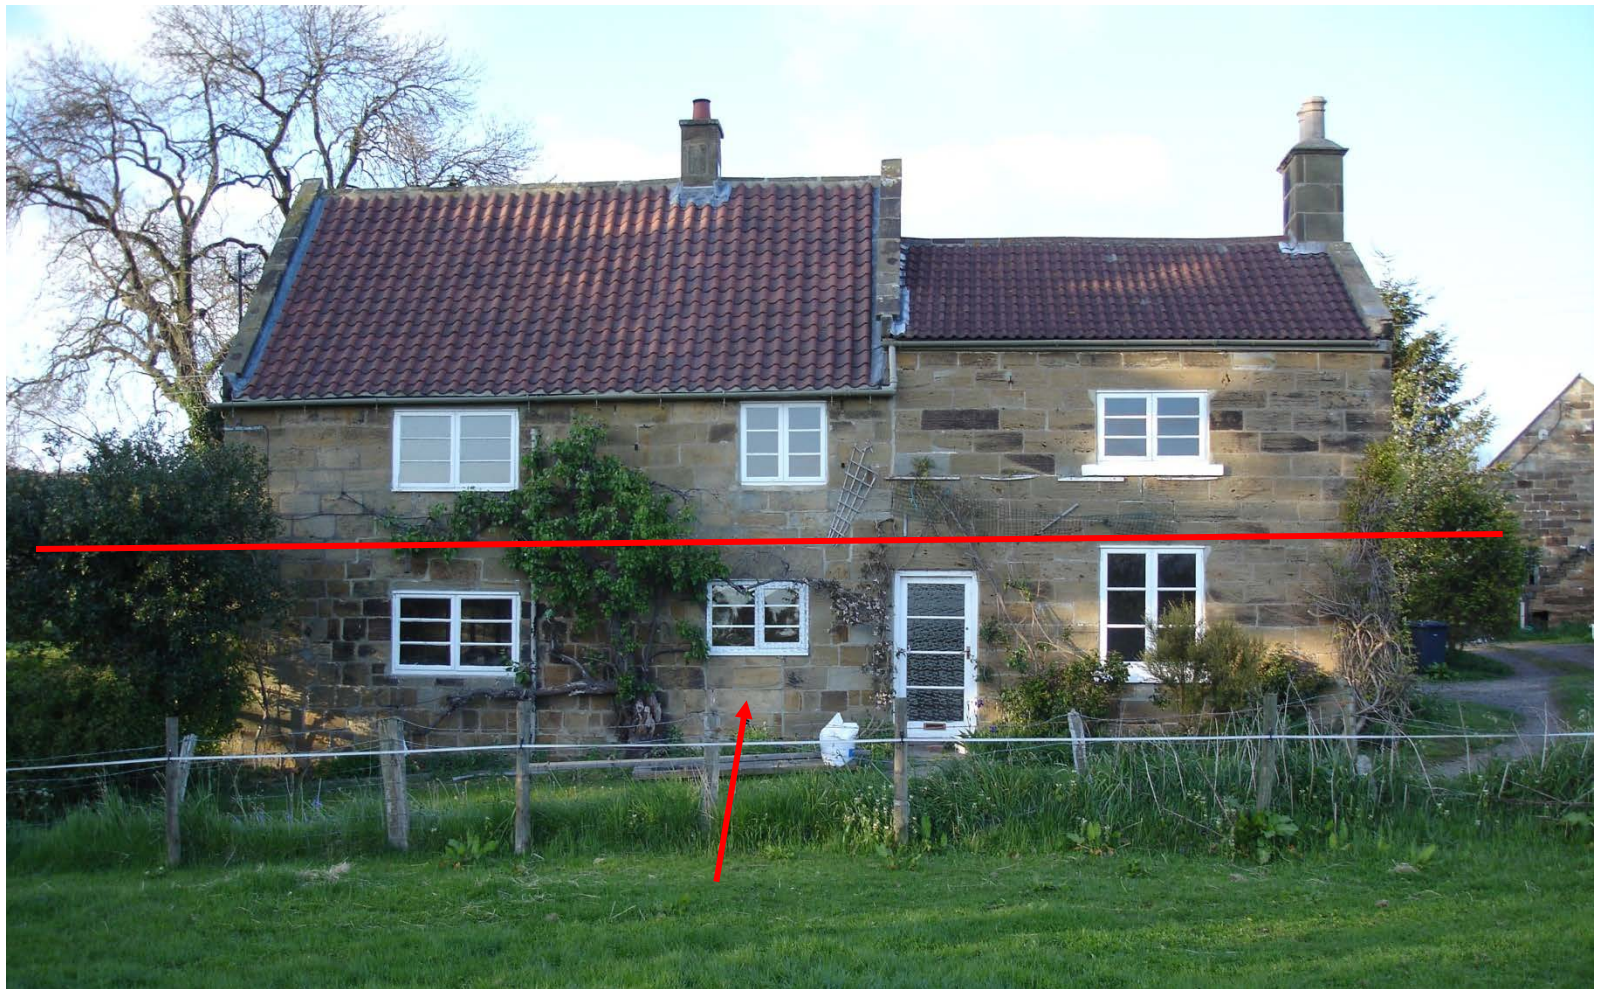
The cross-passage, now blocked off, is exactly in the middle of the building.

The massive stone lintel above the original cross-passage entrance, far bigger than would be needed for the present kitchen window, window, is vital evidence in understanding the building.

Closer examination shows that the cross-passage entrance has been blocked up below the present window.

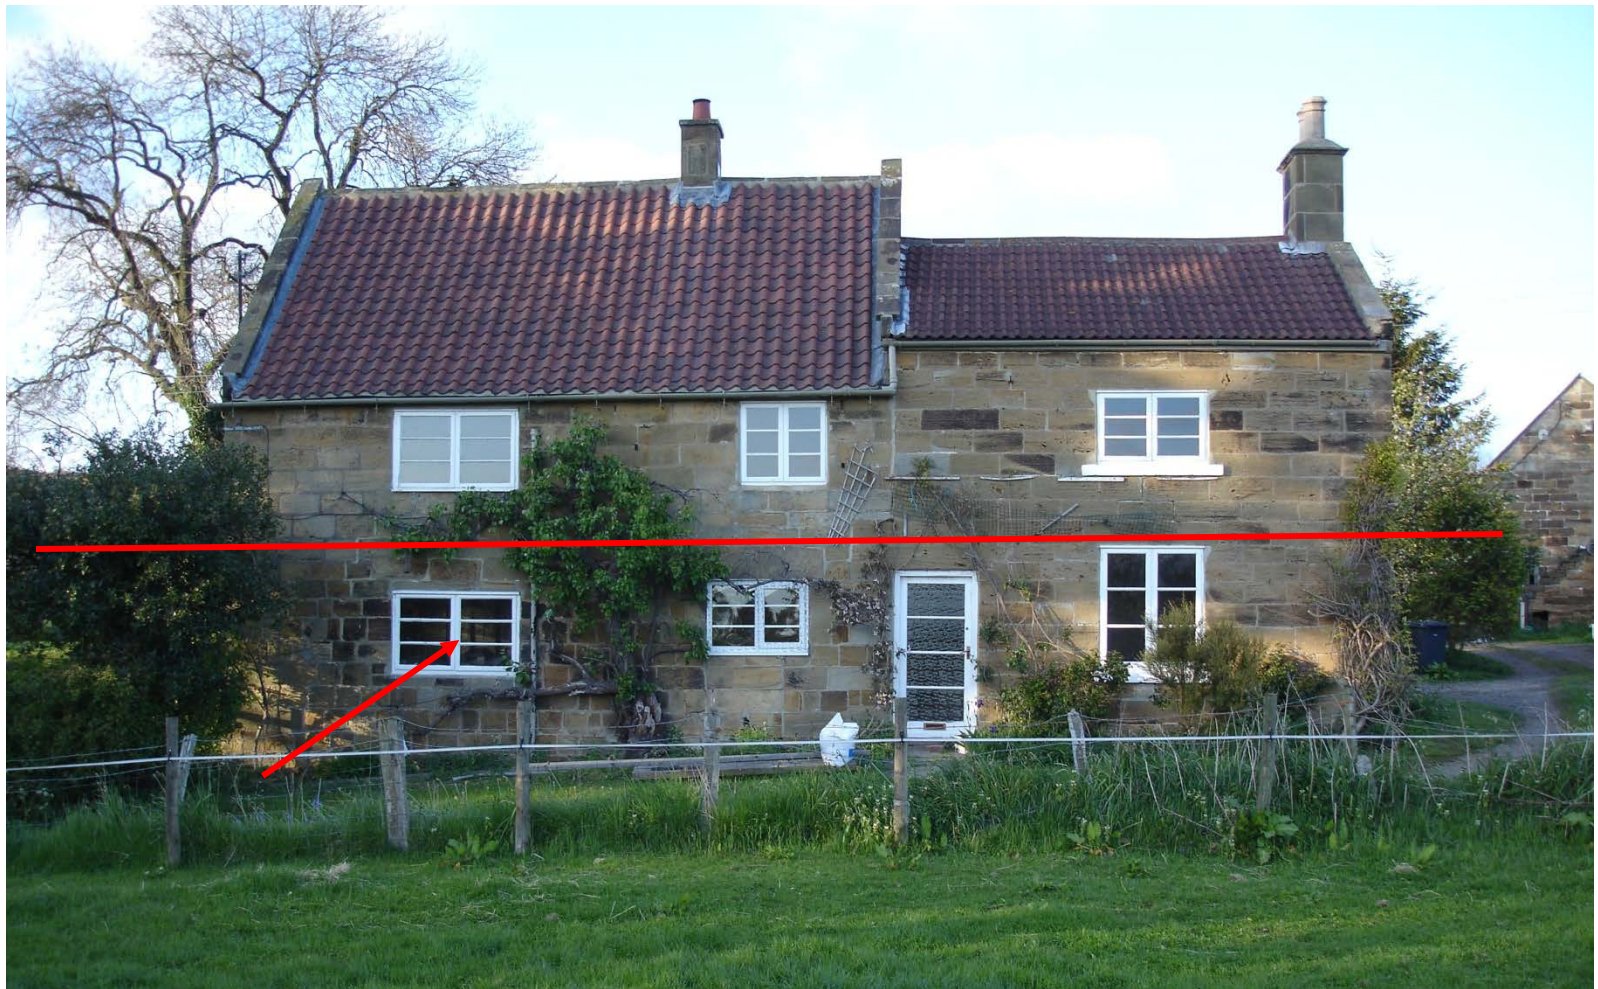
This was originally a stone mullioned window, giving light into the forehouse.

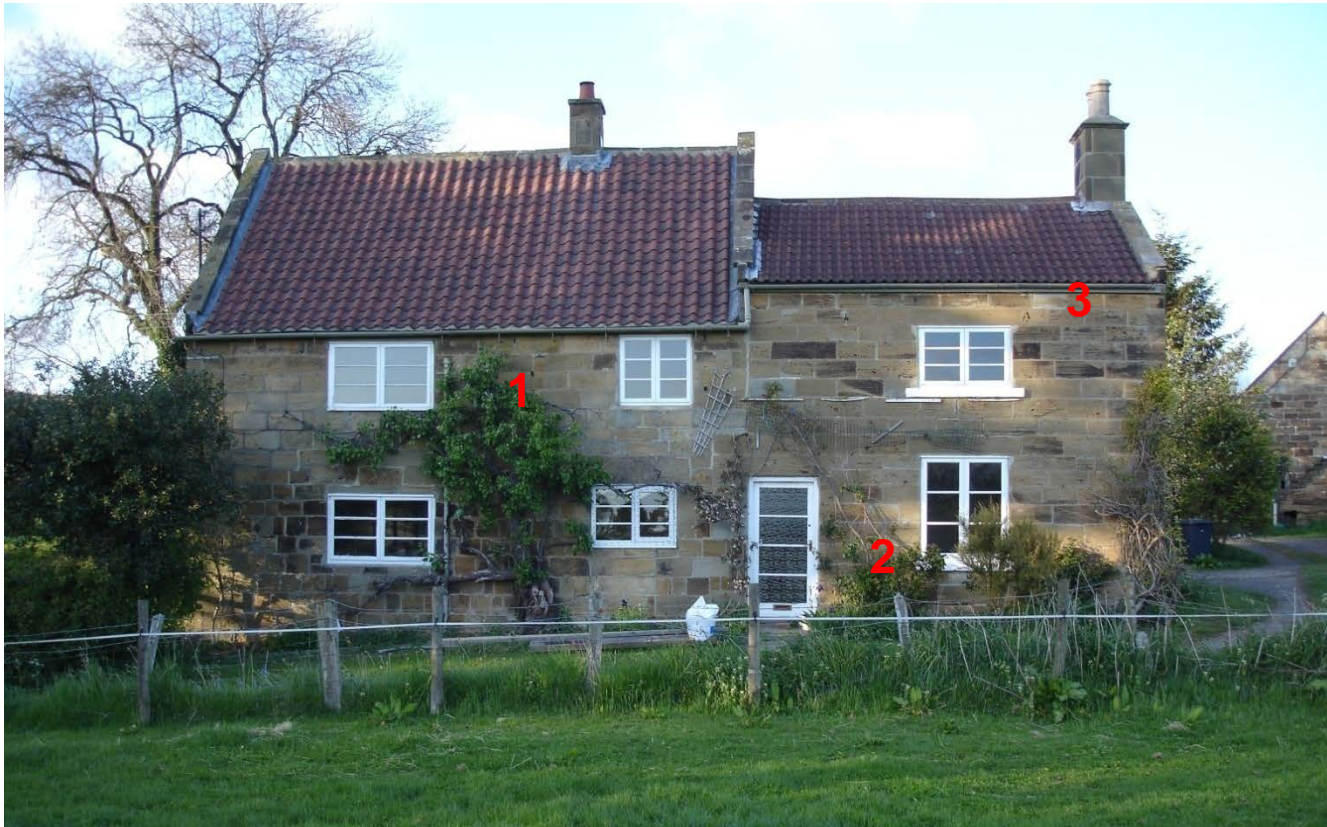
Probable sequence of modifications at Brookside Farm

- 1** Forehouse raised to provide upper floor, late 1700s
- 2** Byre end demolished
- 3** Byre end totally rebuilt on original plinth, early 1800s
continued on next slide

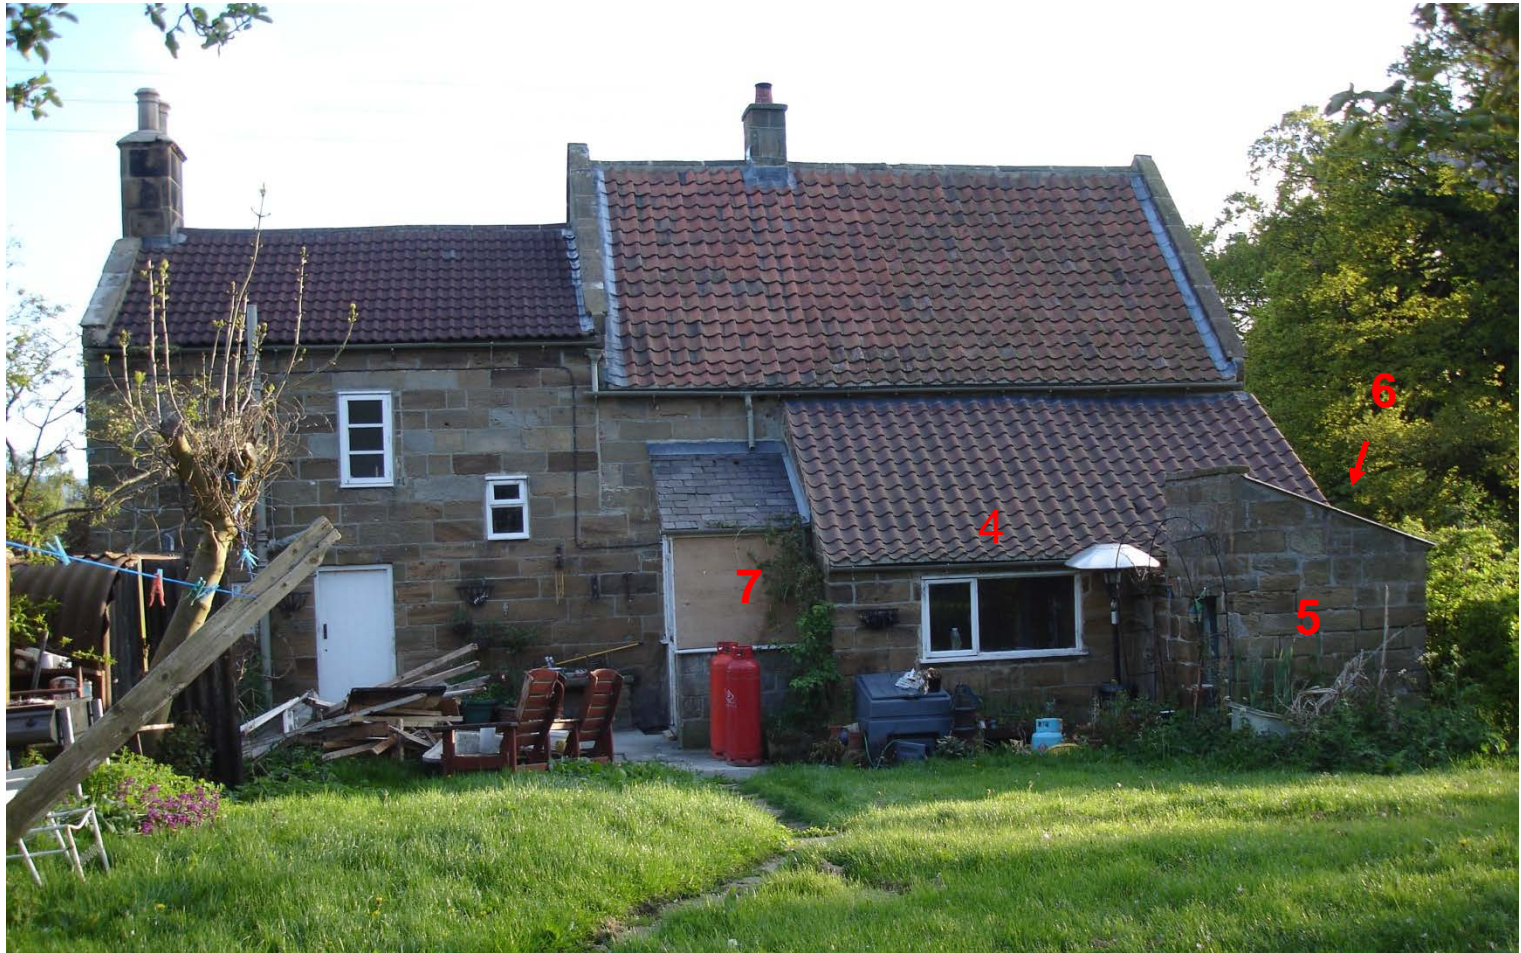
- 4 Lean-to built
- 5 Free-standing privy built
- 6 Gap between privy and lean-to filled with duck house or pigsty
- 7 Outside porch added

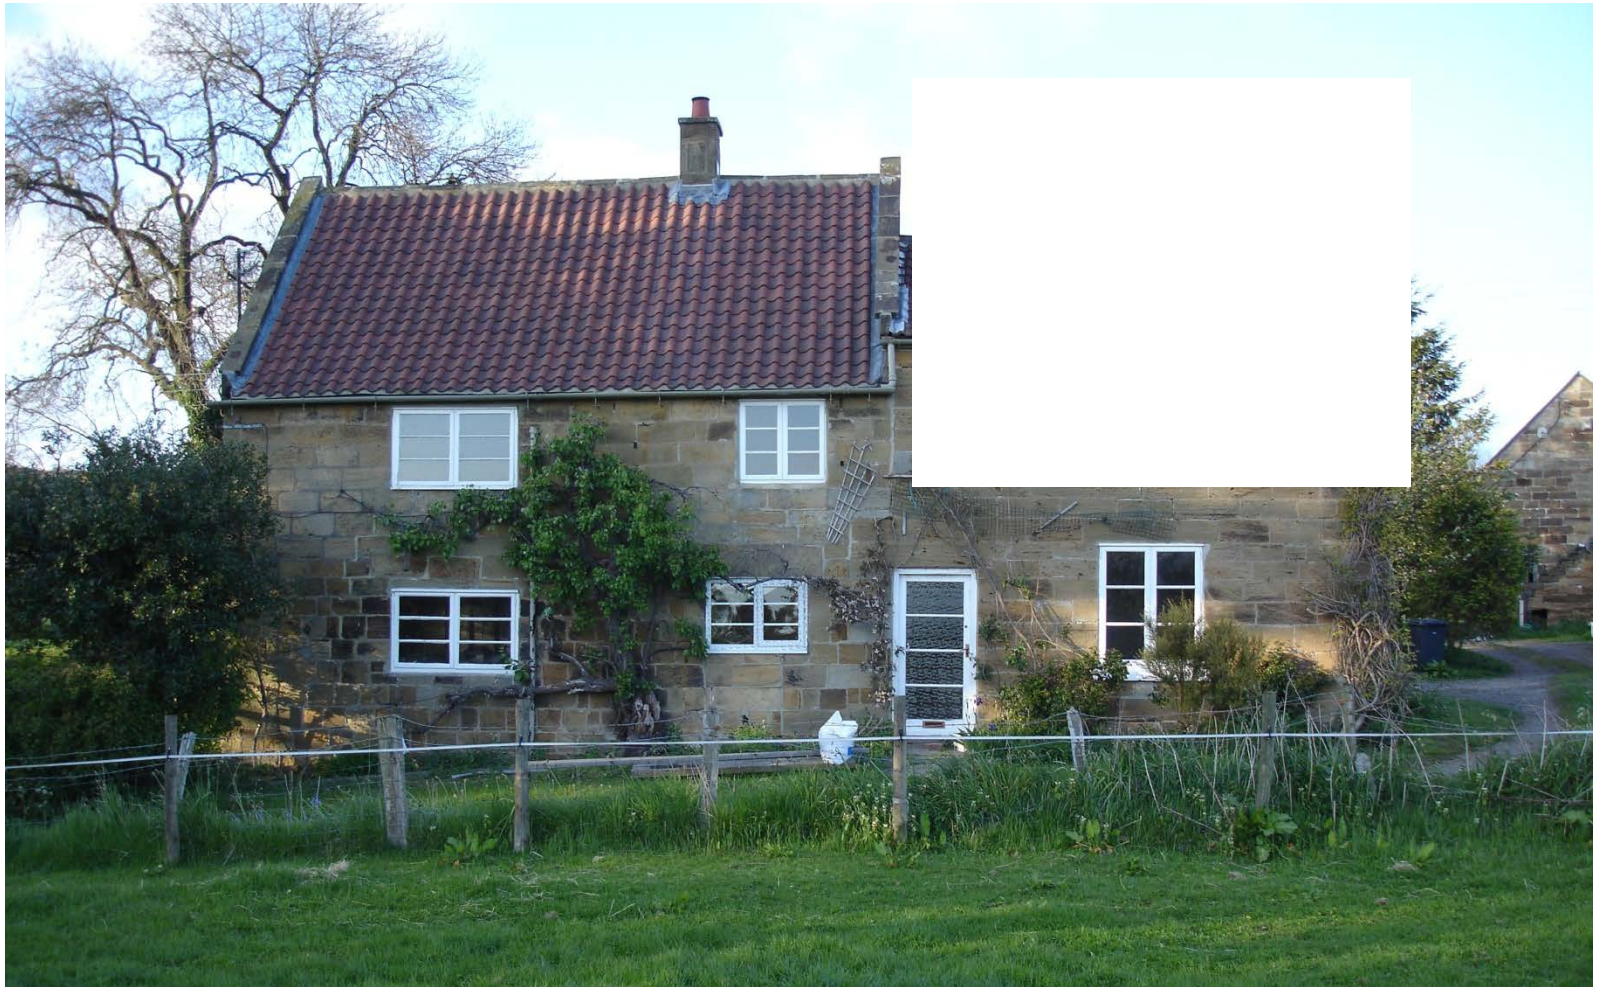
The first major modification would have been to raise the walls of the forehouse to give an upper storey, so as to increase living space. The upper walls use 10" stones, thinner than the original 18" walls below.

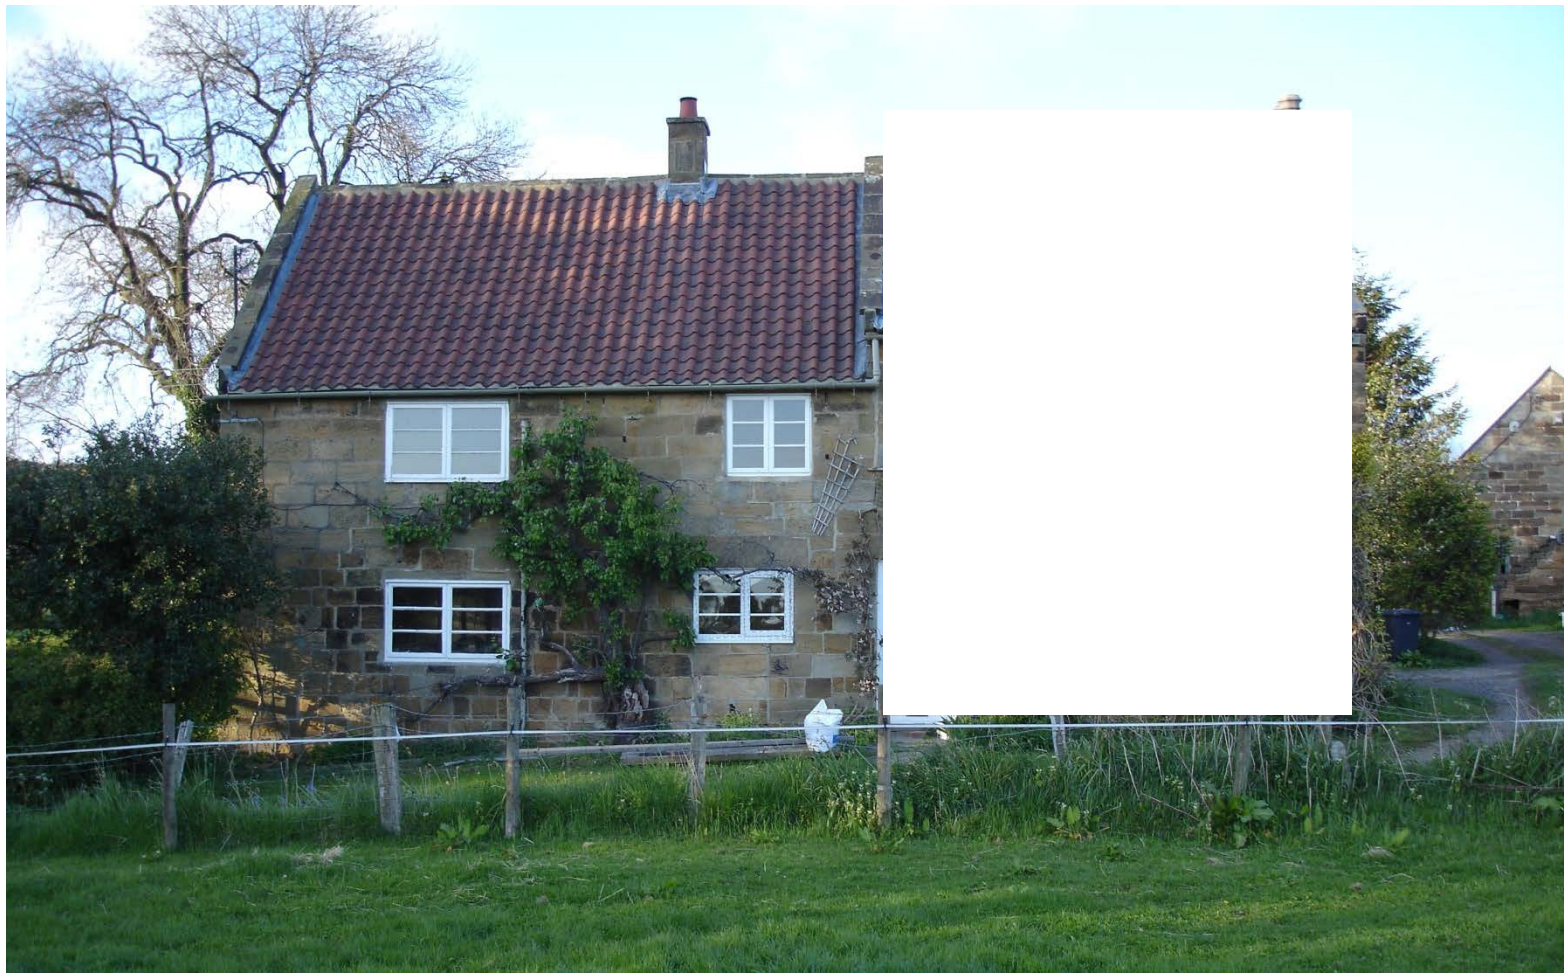
The animals would have been evicted from the byre end, which was then demolished.

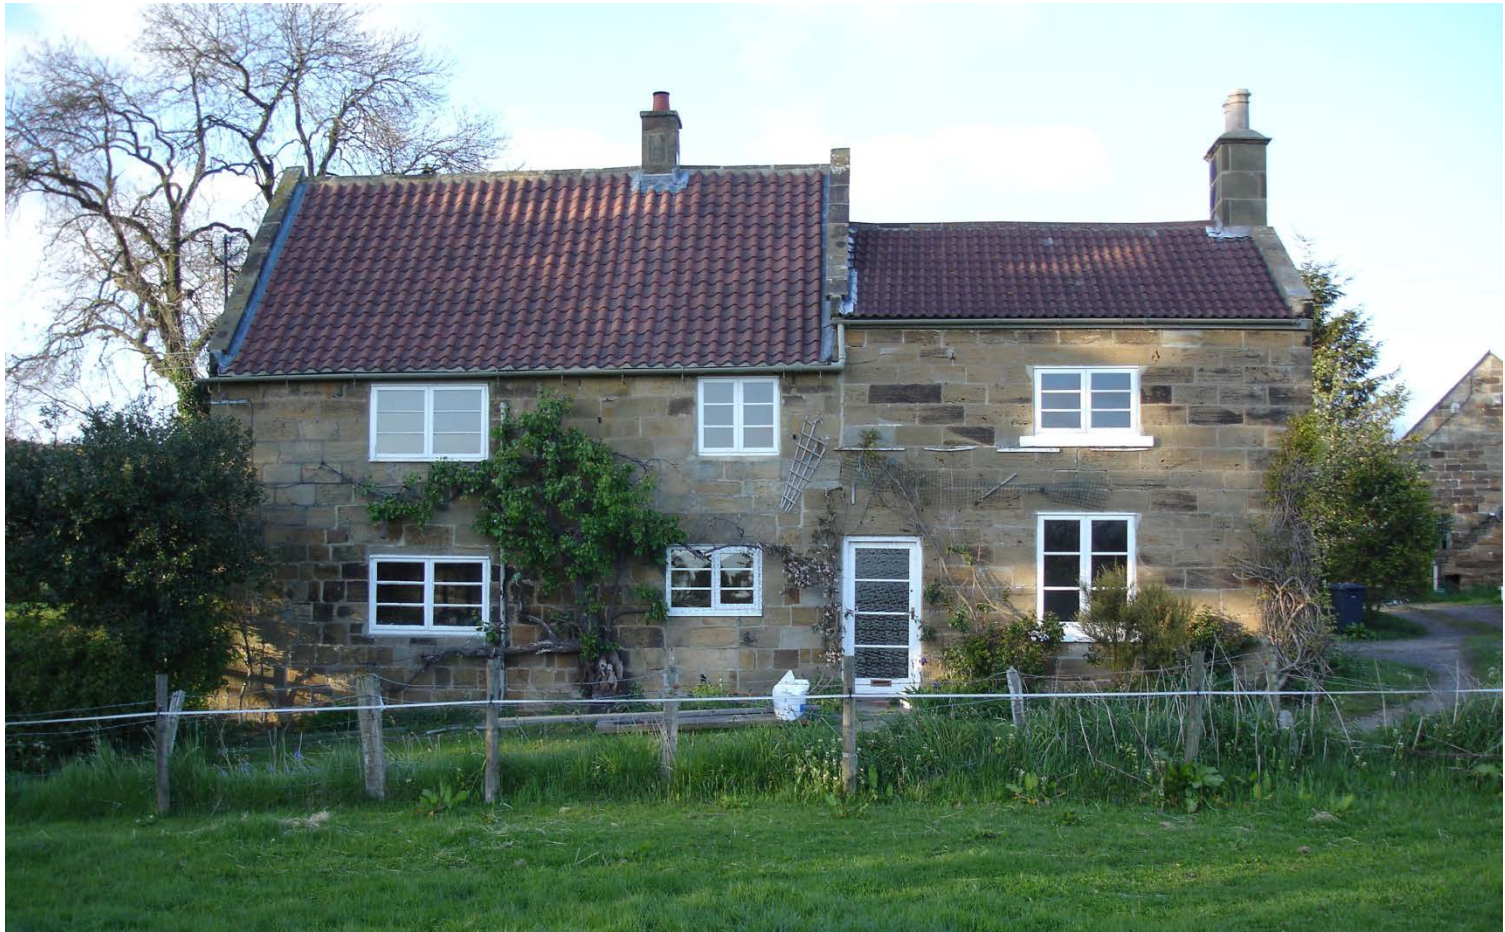
The byre end was then rebuilt, re-using some of the original stone with some new stone. It had 10" thick walls, a slate roof and internal walls in brick. A new staircase gave access to the upper floor, and a doorway was opened up in what had been the external gable-end wall of the forehouse, now an internal wall between the old and new upper floors.

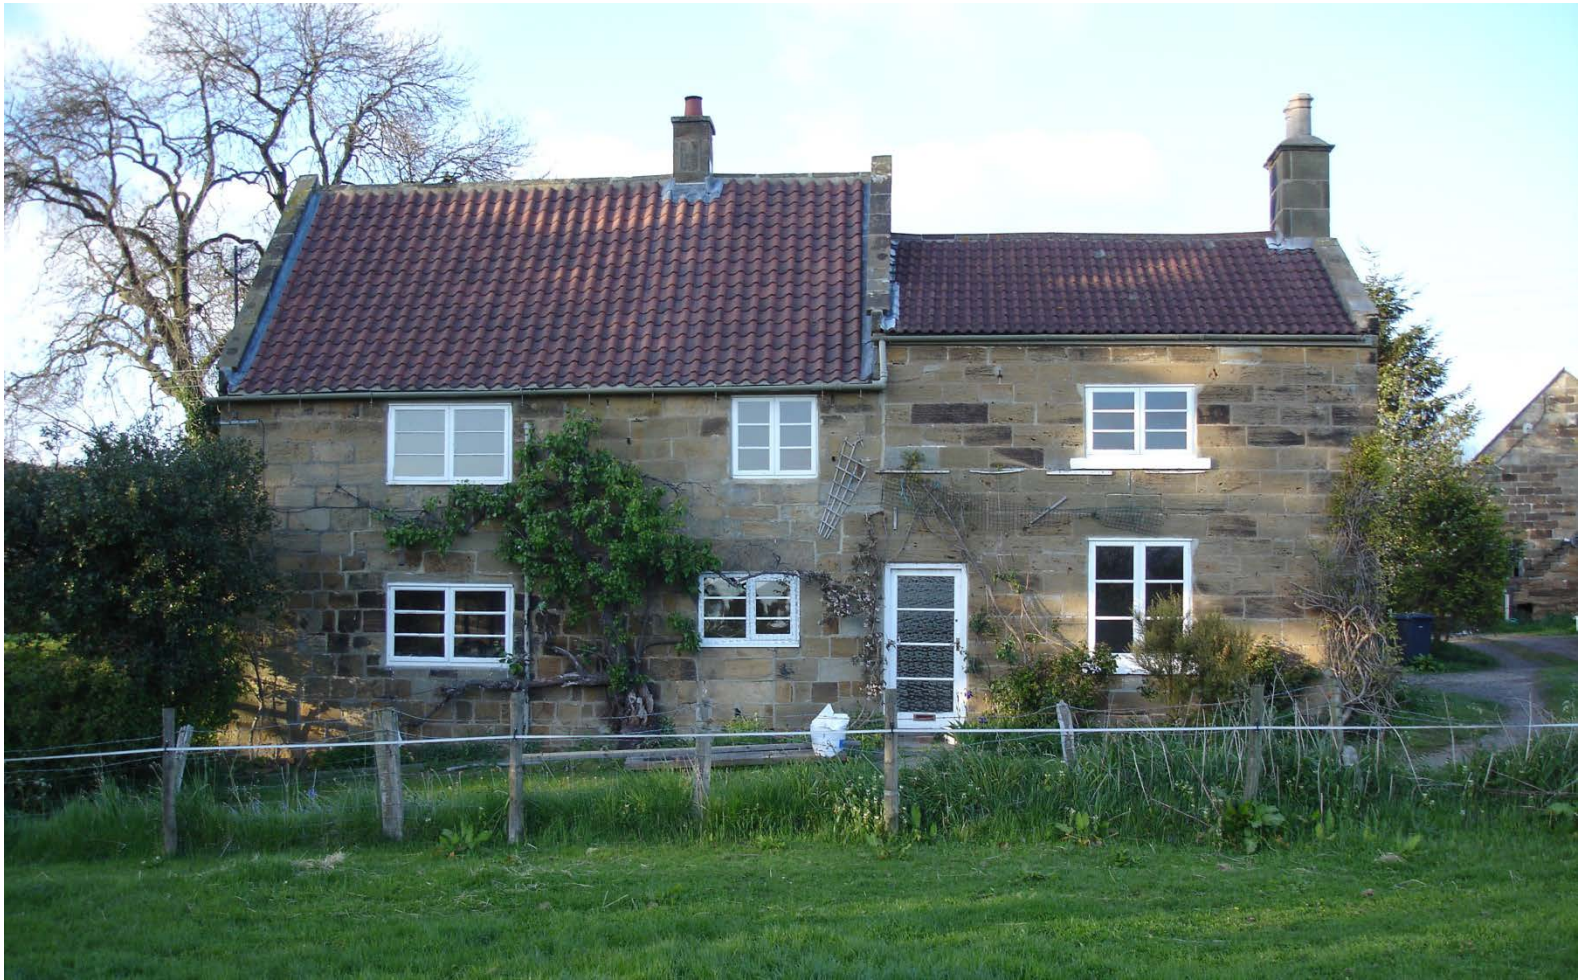
The wood-framed windows are now a modern assortment of wooden framed, but earlier some would have been the traditional 'Yorkshire slides', with their horizontally-sliding sashes. The evidence for this is in the dimensions of the window openings, relatively wide but lacking in height.

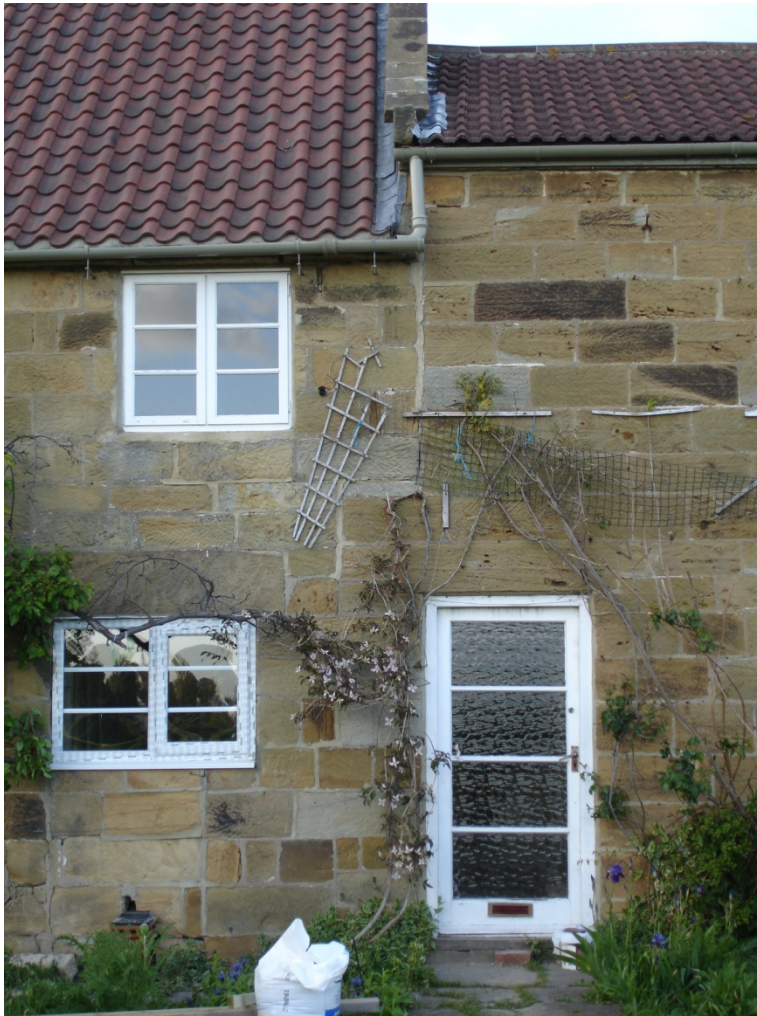
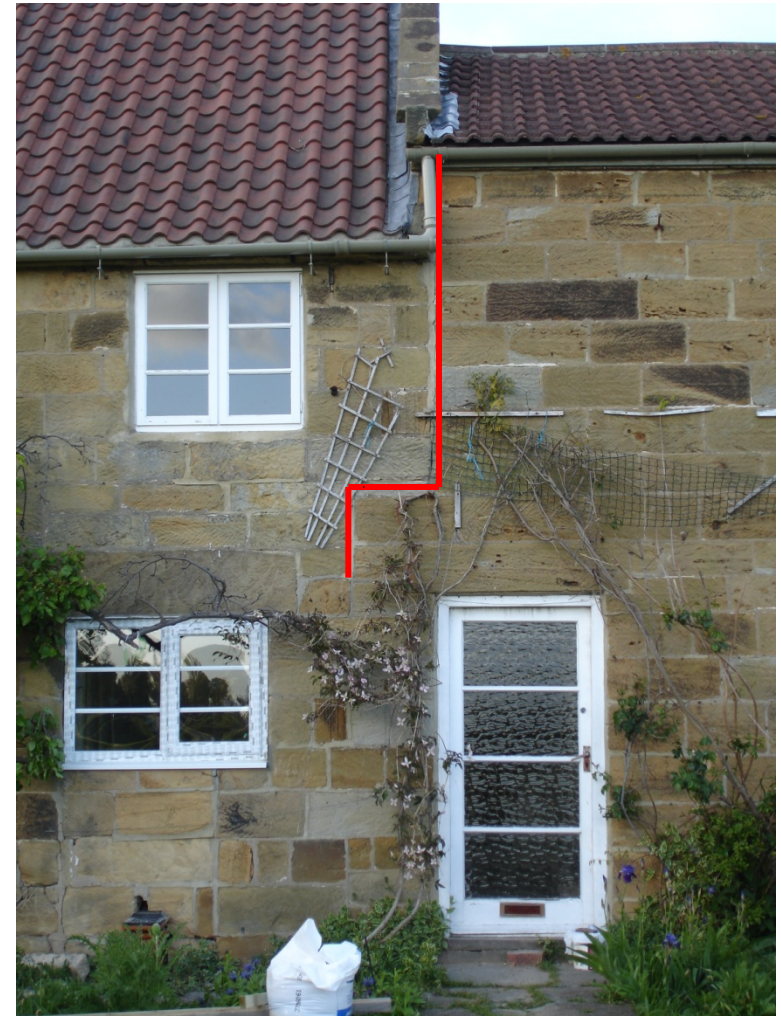
The join between the rebuilt byre end and the forehouse (which had been previously raised to an upper floor) provides evidence for the rebuilding.

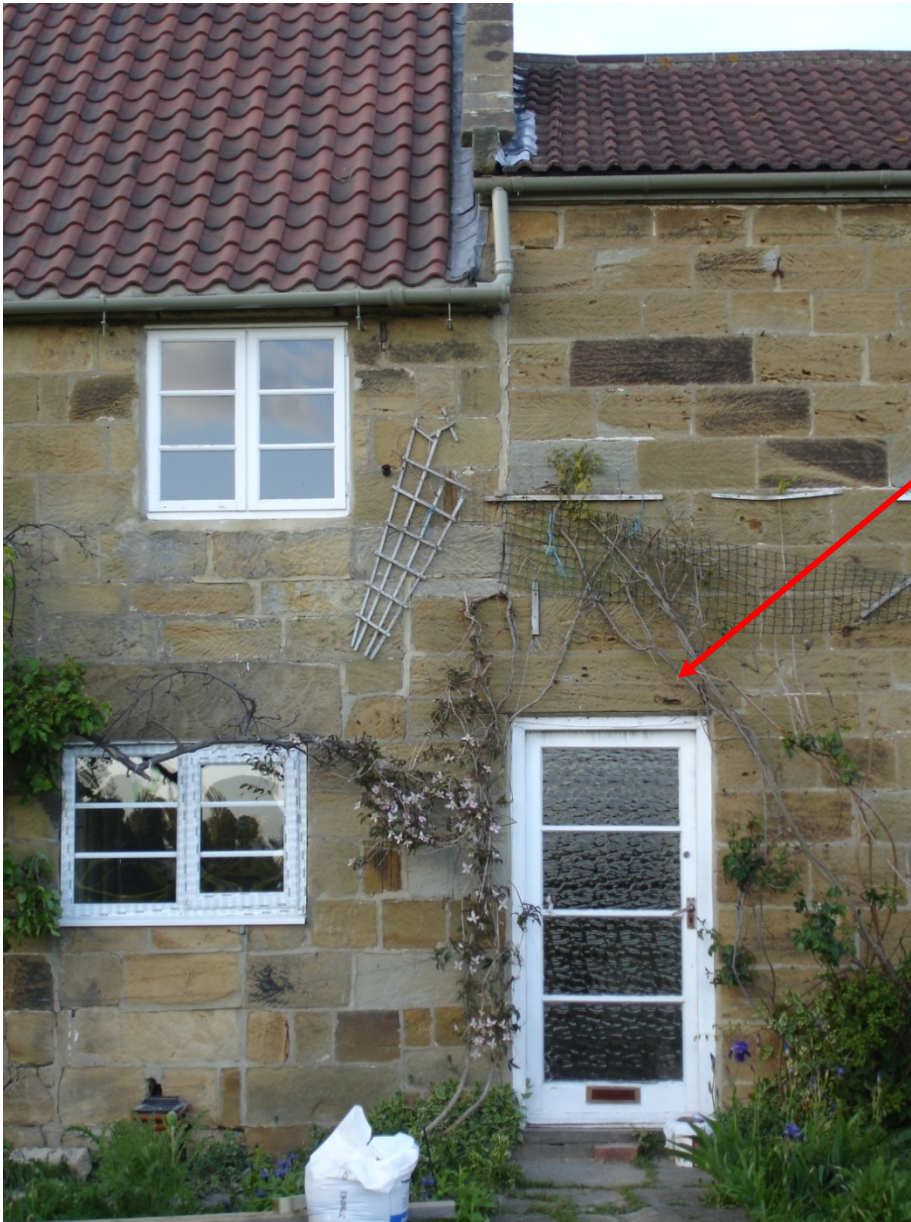
The rebuilt byre end had a new front entrance. This replaced the old cross-passage entrance to the left, which was filled with stonework and a new window.

Inside, the right hand wall of the cross-passage was knocked down, and rebuilt over to the right, doubling the width of the old cross-passage and allowing it to be converted into a new kitchen.
