BROOKSIDE FARM, LITTLE AYTON

A cross-passage farmhouse of historical importance

Brookside Farm was surveyed by members of the Great Ayton Community Archaeology Project (Cath Small, Ken Taylor, Bob de Wardt, Dave Taylor and Ian Pearce) in May 2009.

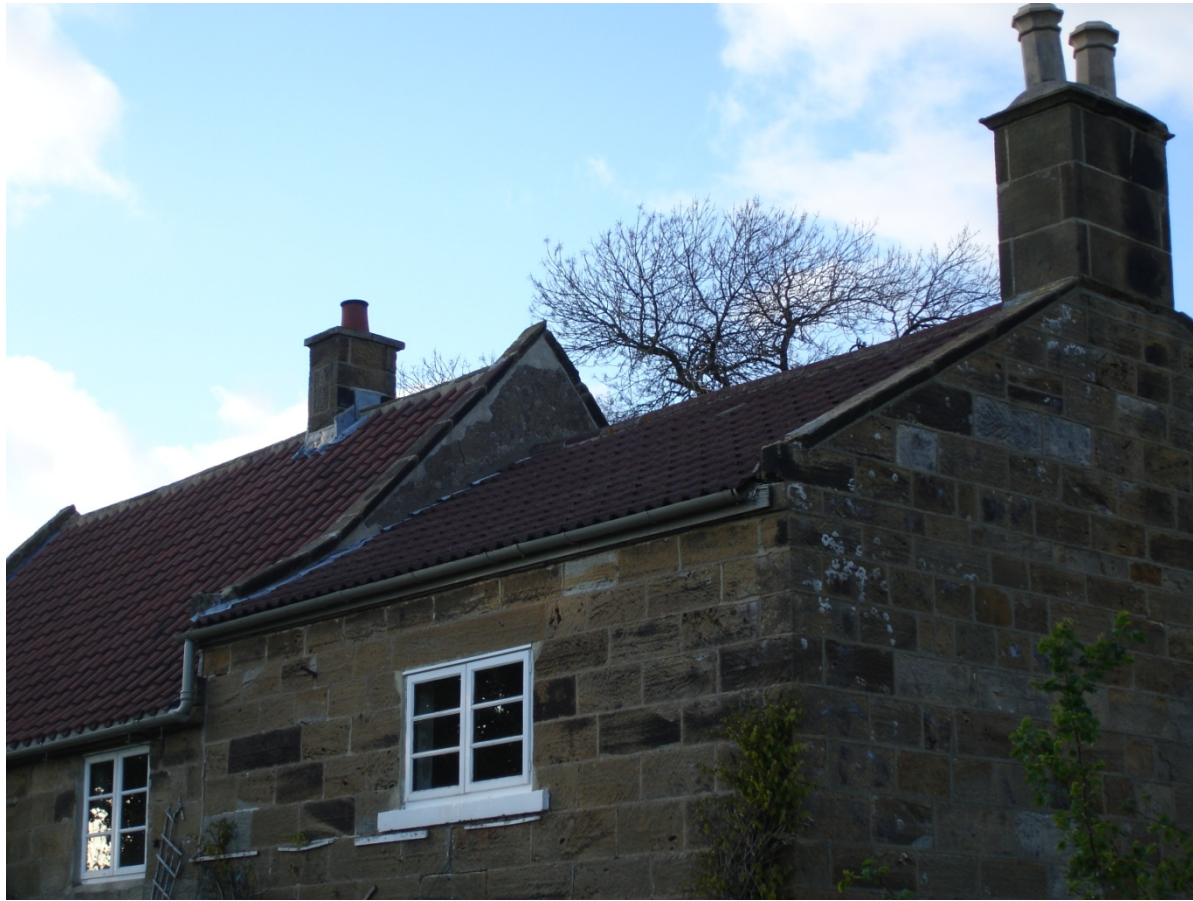
When the fore-house was raised, it had a steeply-pitched roof, probably with clay pantiles. When the byre-end was rebuilt, use of slate allowed a shallower pitch. This is now roofed with modern concrete tiles. The fine chimney on the byre-end is, architecturally, the most refined aspect on the entire house. It is very similar to other chimneys in the locality, suggesting the use of the same builder/stone mason.

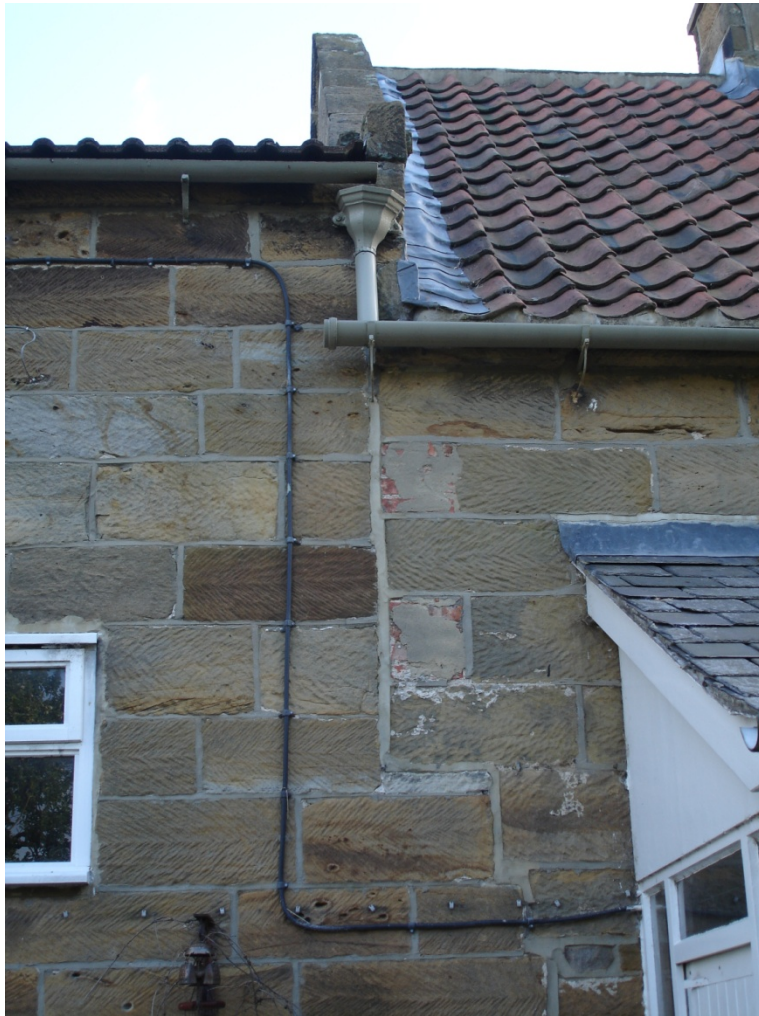
The join between the rebuilt byre-end and the fore-house (previously raised to an upper floor) is clearly visible in the stonework.

The top of the fore-house gable end (now in brick) is exposed but has been rendered over to simulate stone.

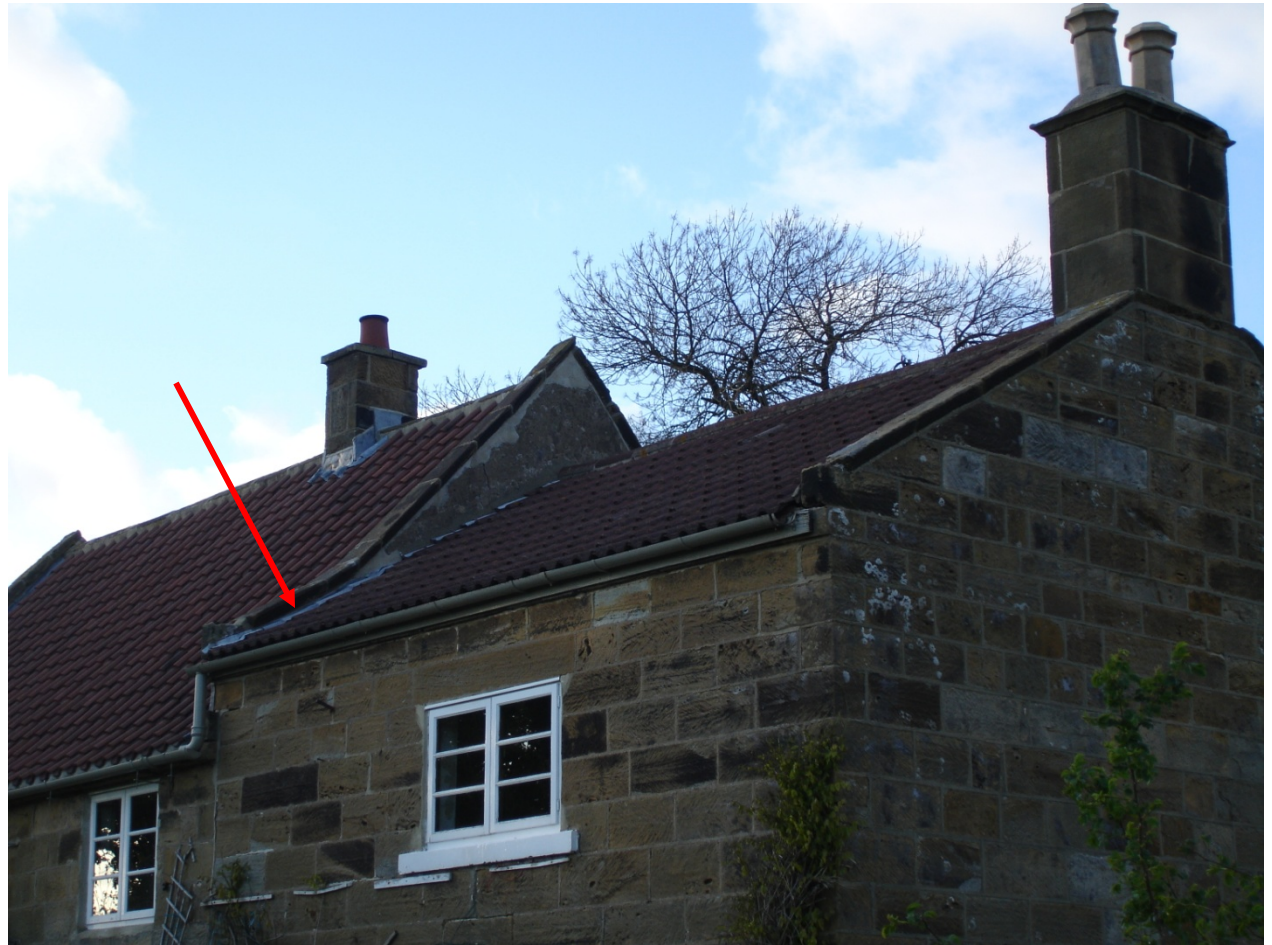
The newly-raised walls of the byre-end were higher than those of the previously-raised fore-house, so the fore-house gable end wall had to be re-shaped to accommodate the byre-end roof line.

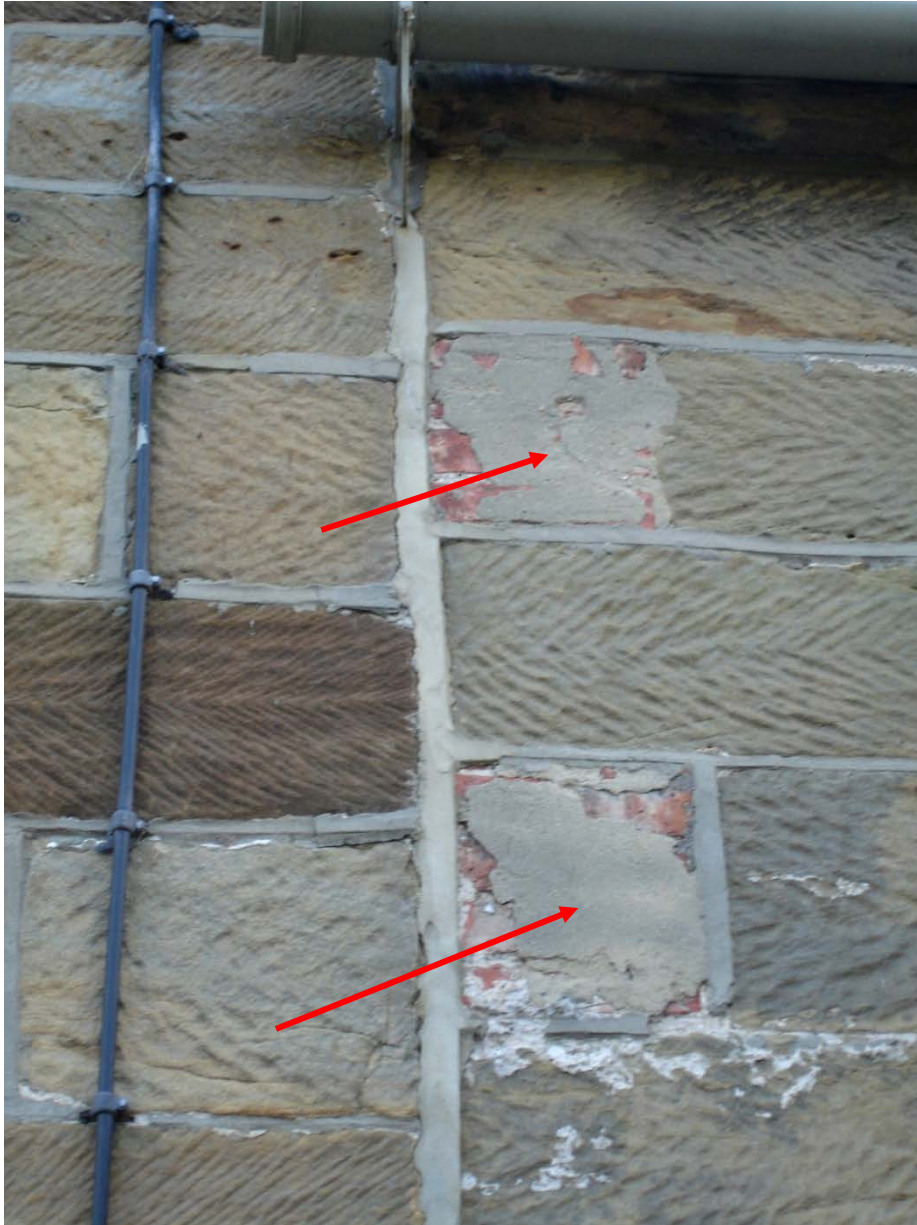
When the byre-end was rebuilt with its upper floor, most of the existing fore-house gable end became an internal wall. It was rebuilt in brick, with the stone no doubt being re-used elsewhere. This brick wall was keyed into the existing stonework of the rear wall, and the exposed bricks rendered over to resemble stone.

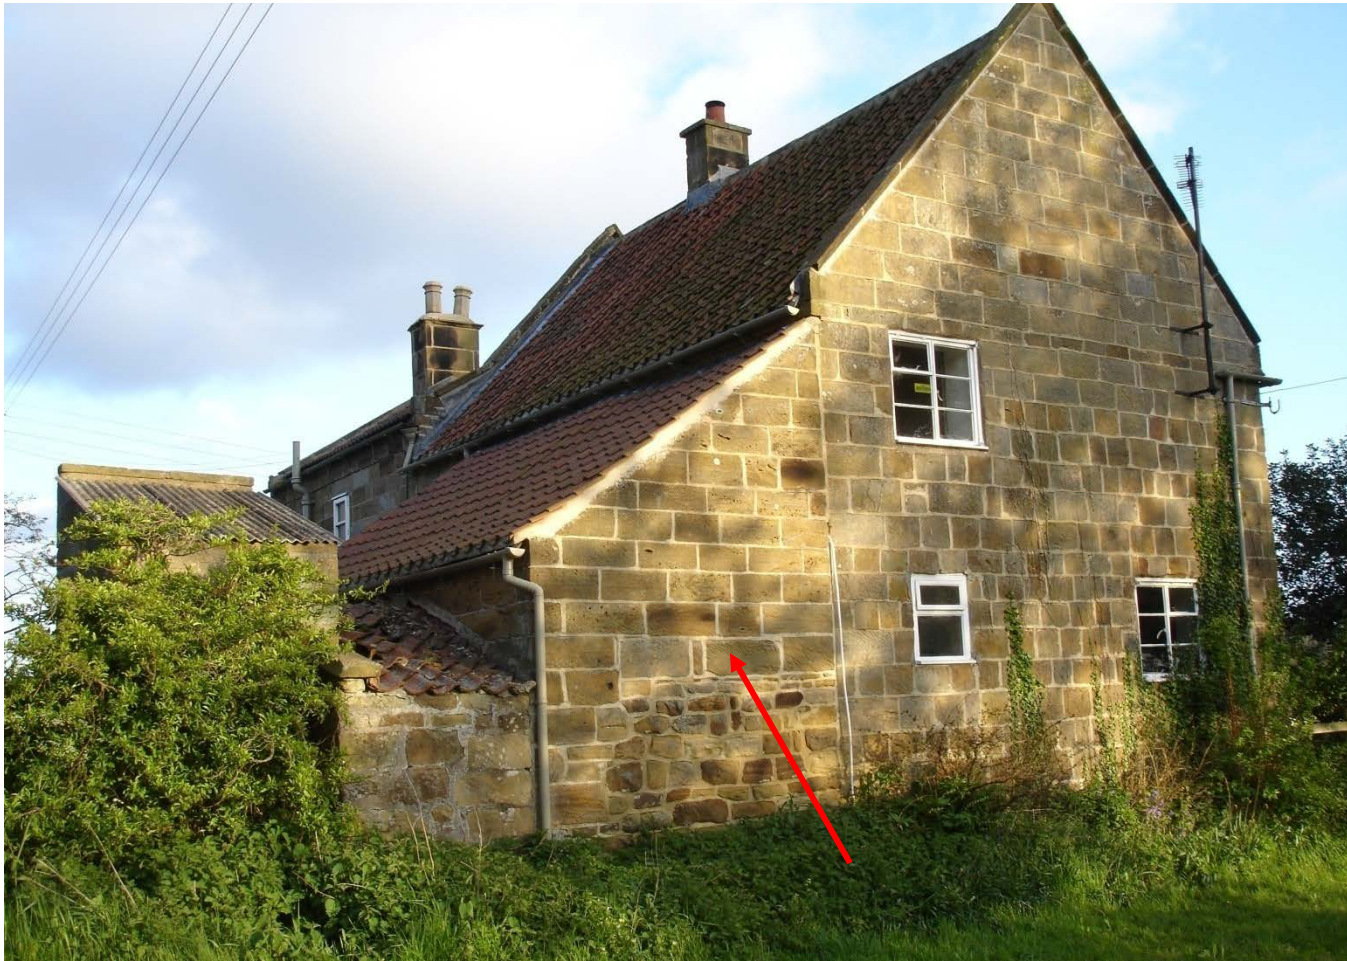
Sometime after the fore-house was raised, a lean-to was built onto the rear. Perhaps surprisingly, the absence of any keying of the new stonework into the existing building has not caused any problems, and there is no cracking visible along the join.

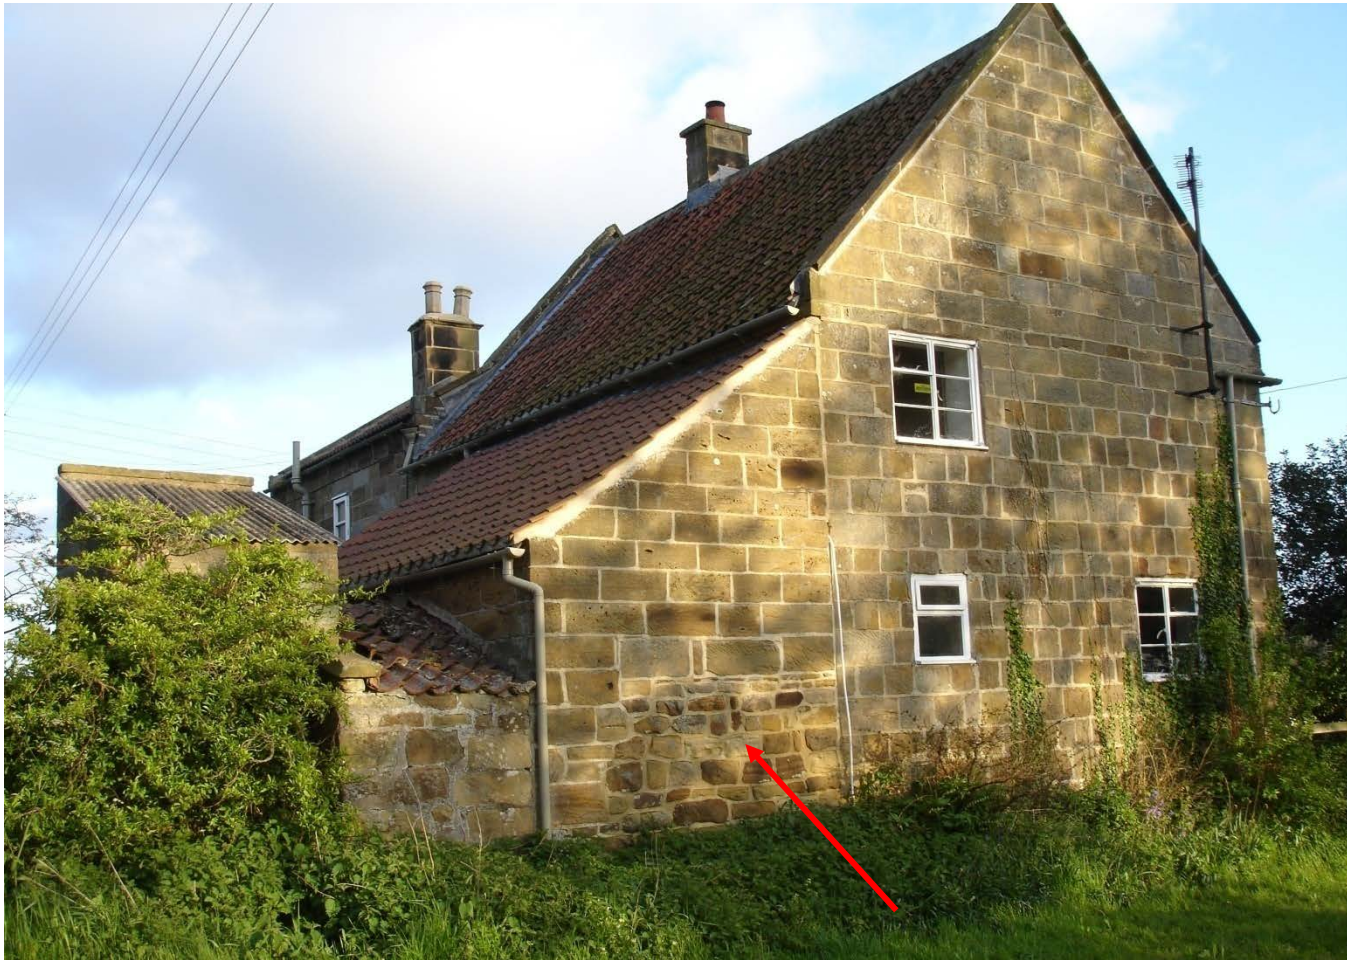
The new extension seems to have incorporated a piece of wall, with much rougher stonework, that was part of an earlier, much smaller, lean-to.

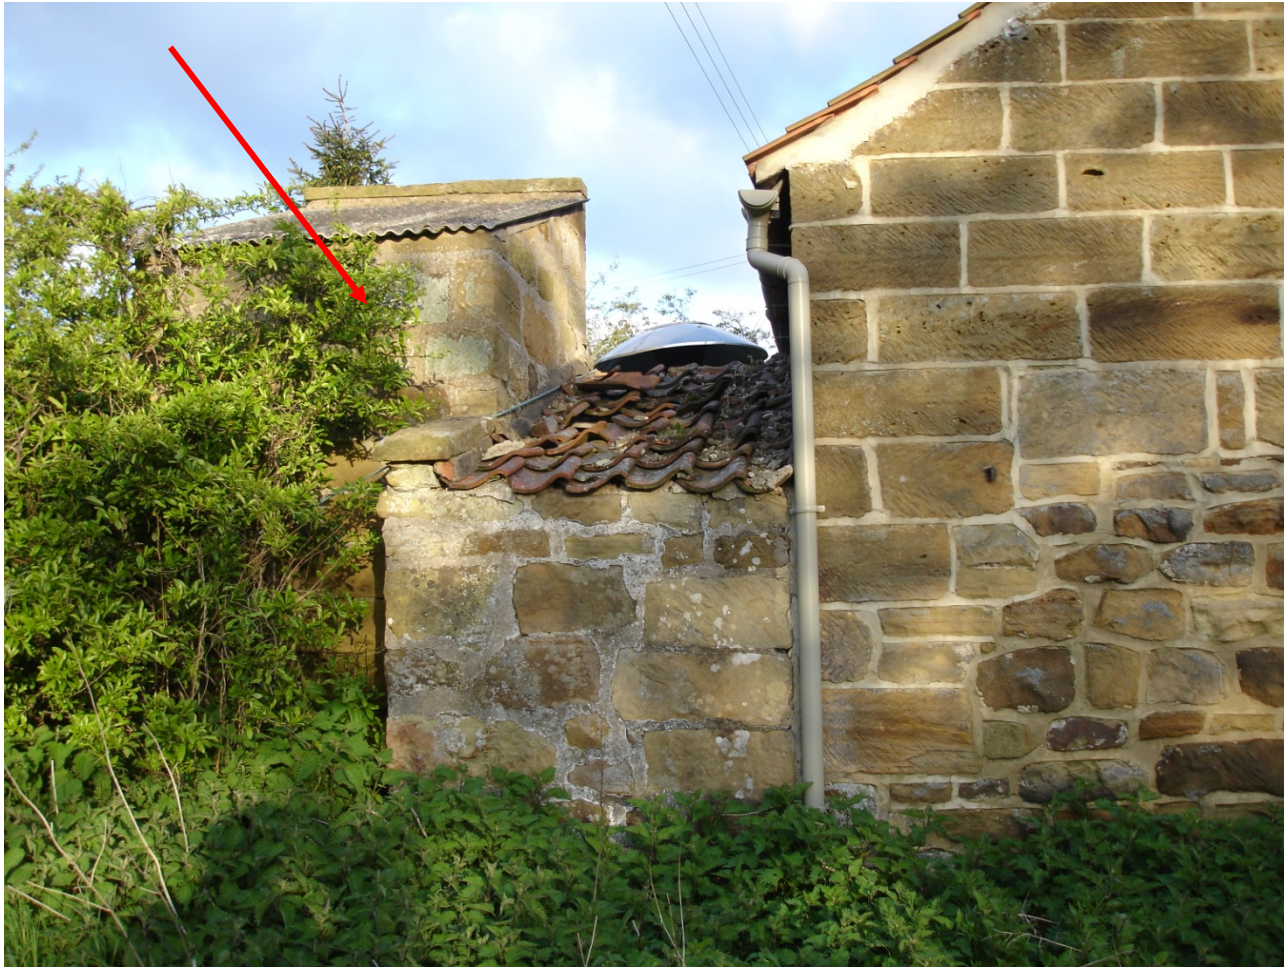
The traditional toilet arrangements for country dwellings was the earth closet; a hole in the ground with a plank across it. For obvious reasons this was housed in a small privy outside the house.

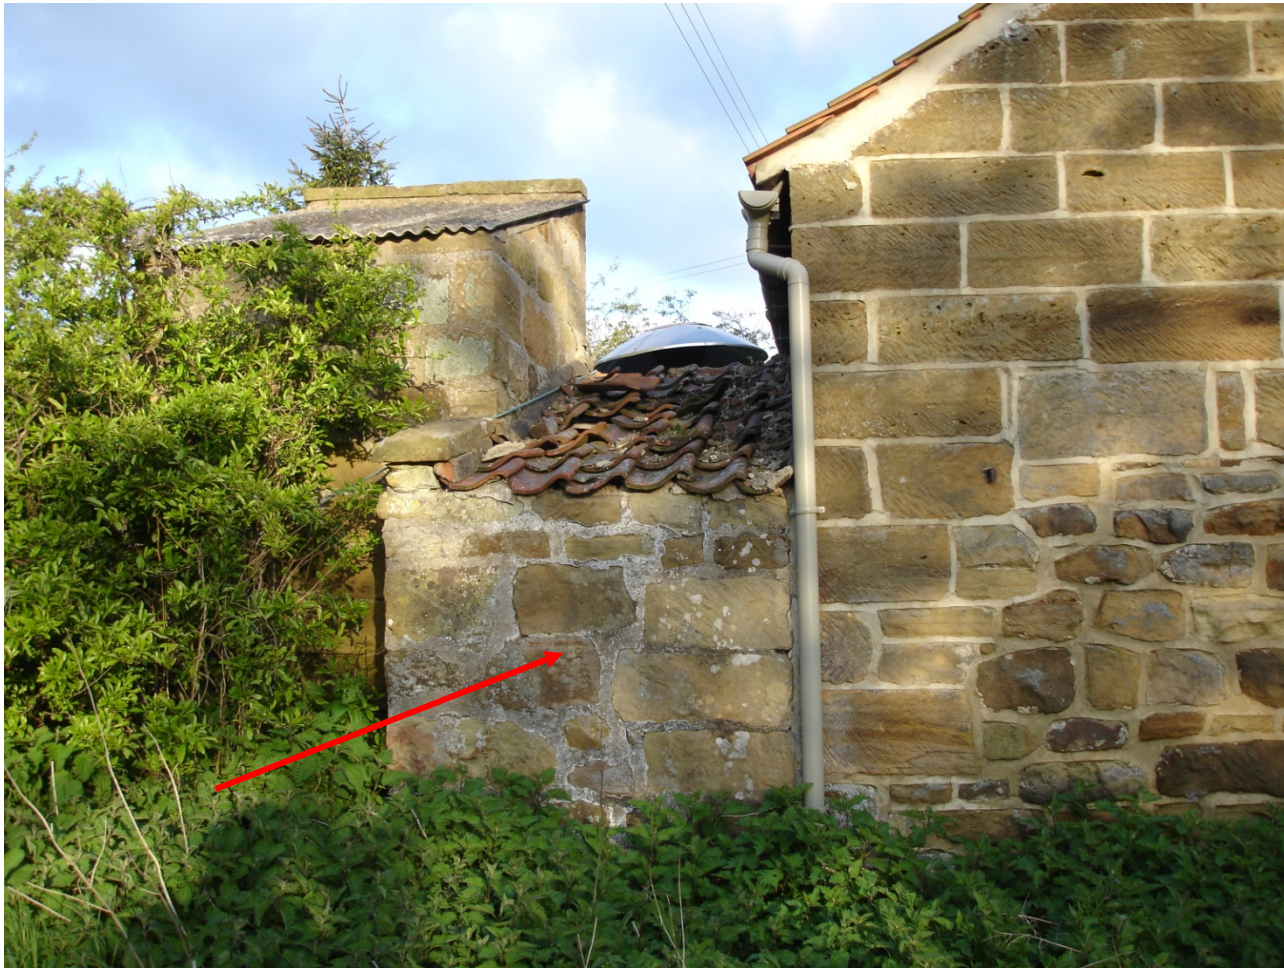
The gap between the privy and the lean-to was then filled in with a small building – a duck house or possibly a pigsty.

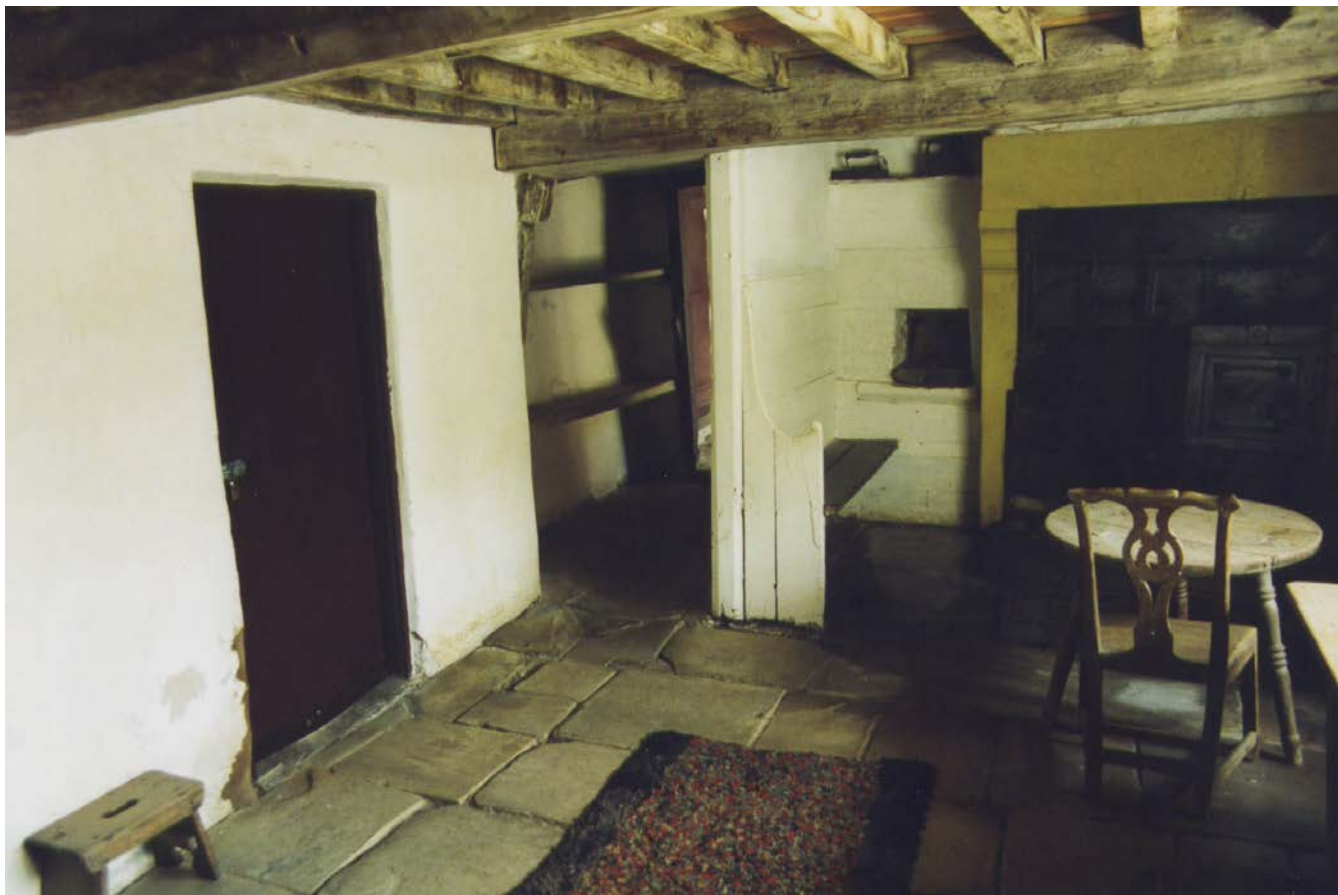
The arrangement of the fore-house at Brookside Farm would have been very similar to that of Spout House at Bilsdale, shown here. The entrance to the fore-house, from the cross passage, is to the left of the hearth. The high-backed settle reduced draughts and provides a cosy seat by the fire.

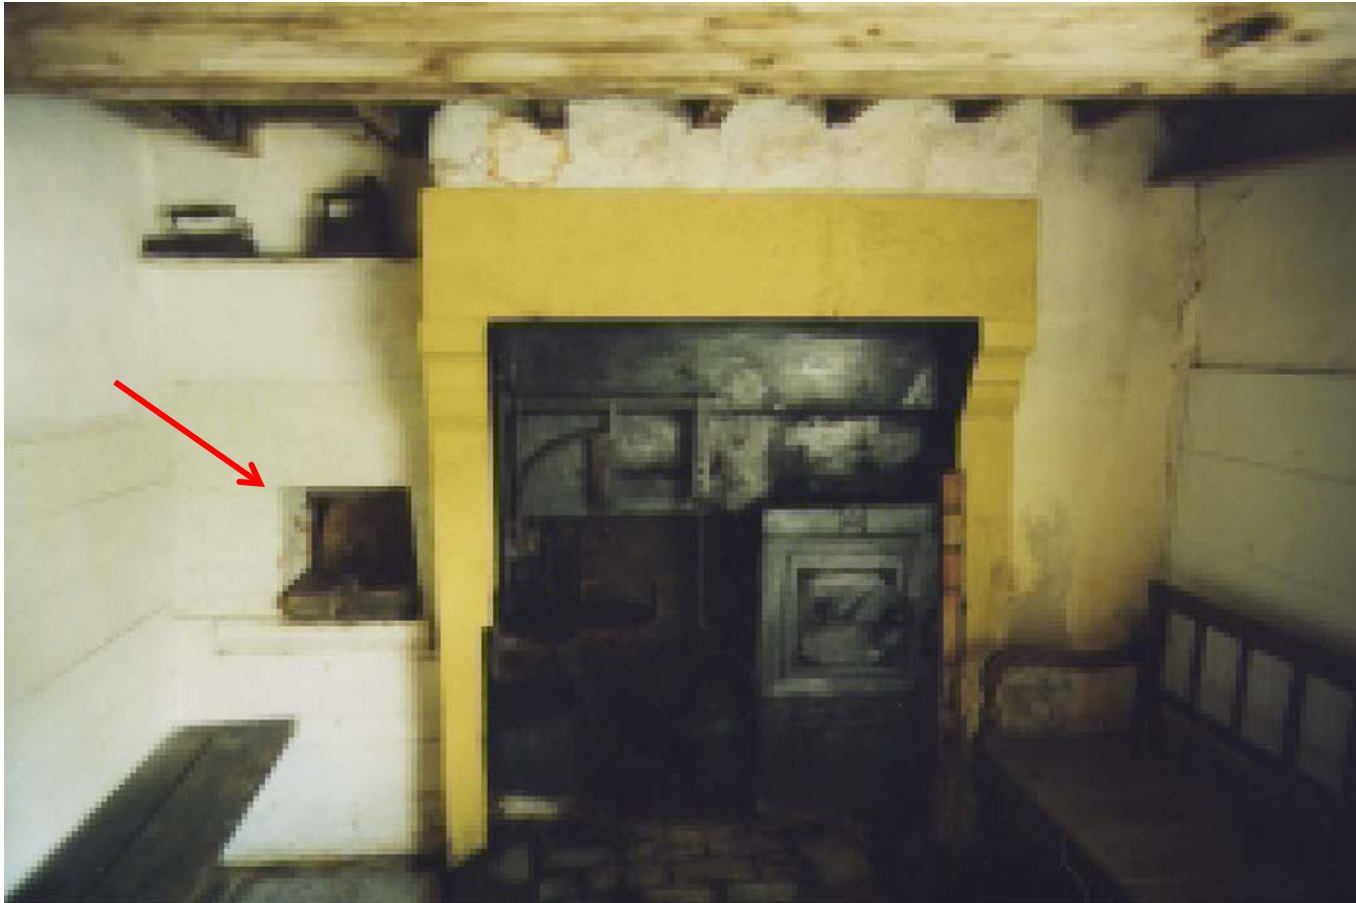
The hearth at Spout House. The range would be a later addition, and would have burned peat or coal. A store cupboard next to the fire, which would have rarely have been let out, was use to store materials that needed keeping dry, especially salt.

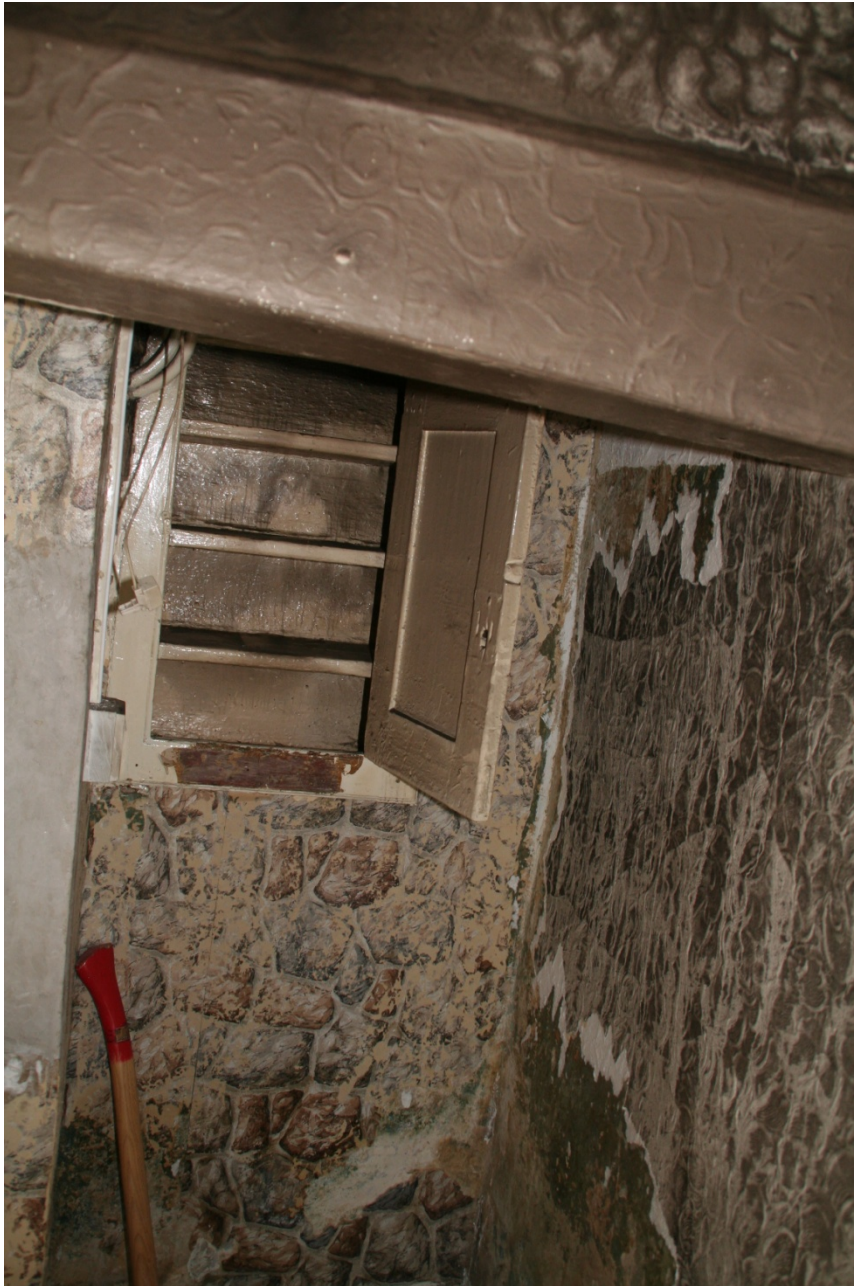
Brookside Farm salt cupboard to the right of the fire place.

The substantial wooden beam across the chimney opening has been covered with wall paper and painted. This shows the changes in fashion; while today exposed beams are much sought-after, previously they were seen as looking better if covered-up.

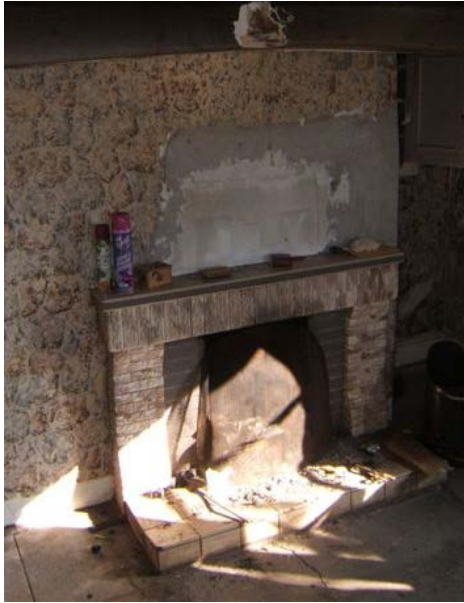
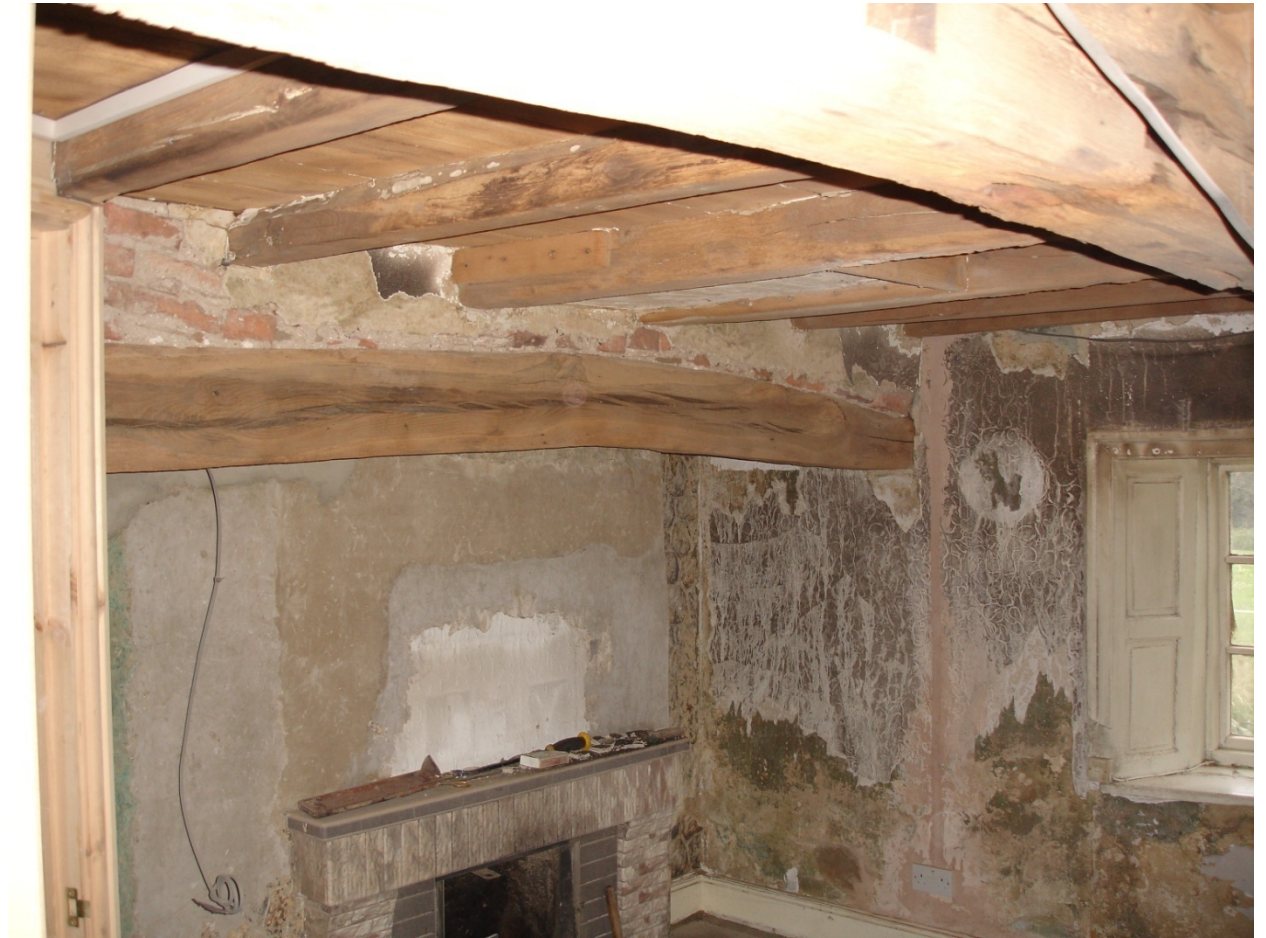
Later work revealed the original beam across the chimney opening. The mid-20th century fireplace look incongruous. Note the wooden panels, probably originally internal shutters, at the side of the window opening.

Hand-made hinges on the salt cupboard door. This 'H' pattern is typical of the 17th and early 18th centuries. They would have been secured with hand-made nails.

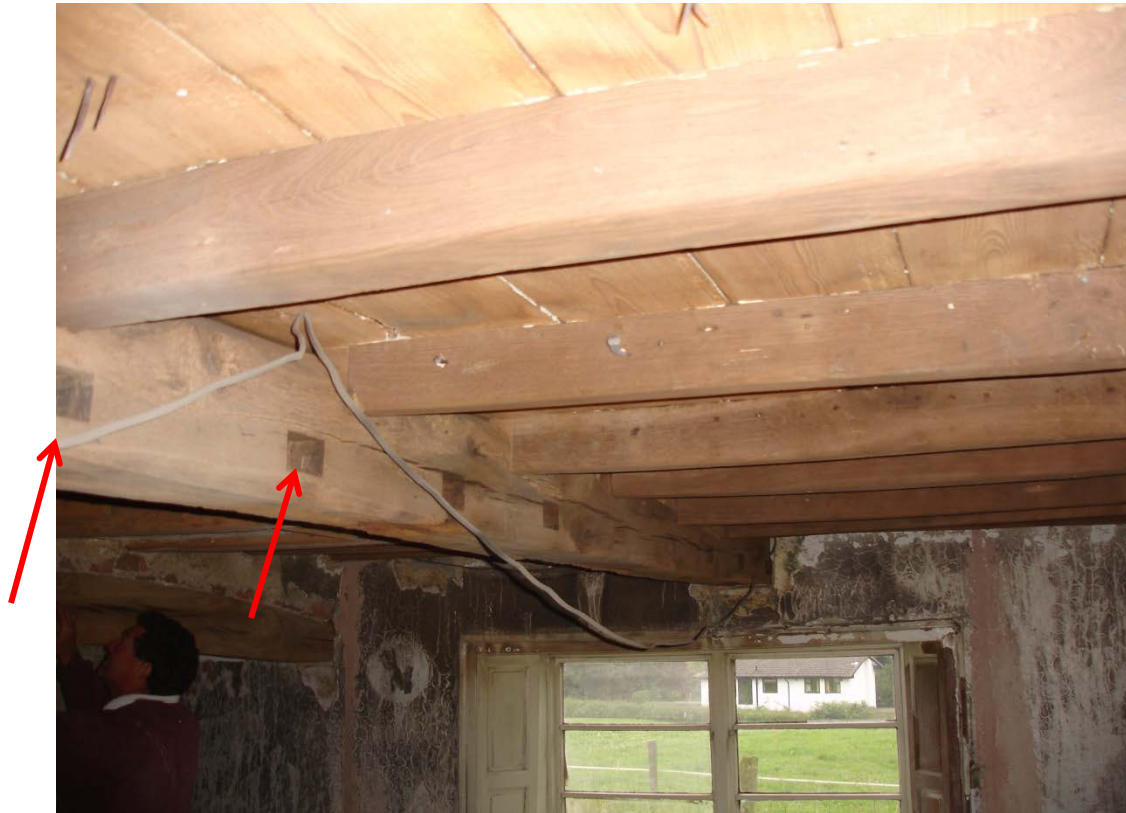
The main beam supporting the upper floor has several holes cut into it which are nothing to do with its present function. These suggest that the beam was previously part of a different structure, and was re-used here. This recycling of beams was fairly common.

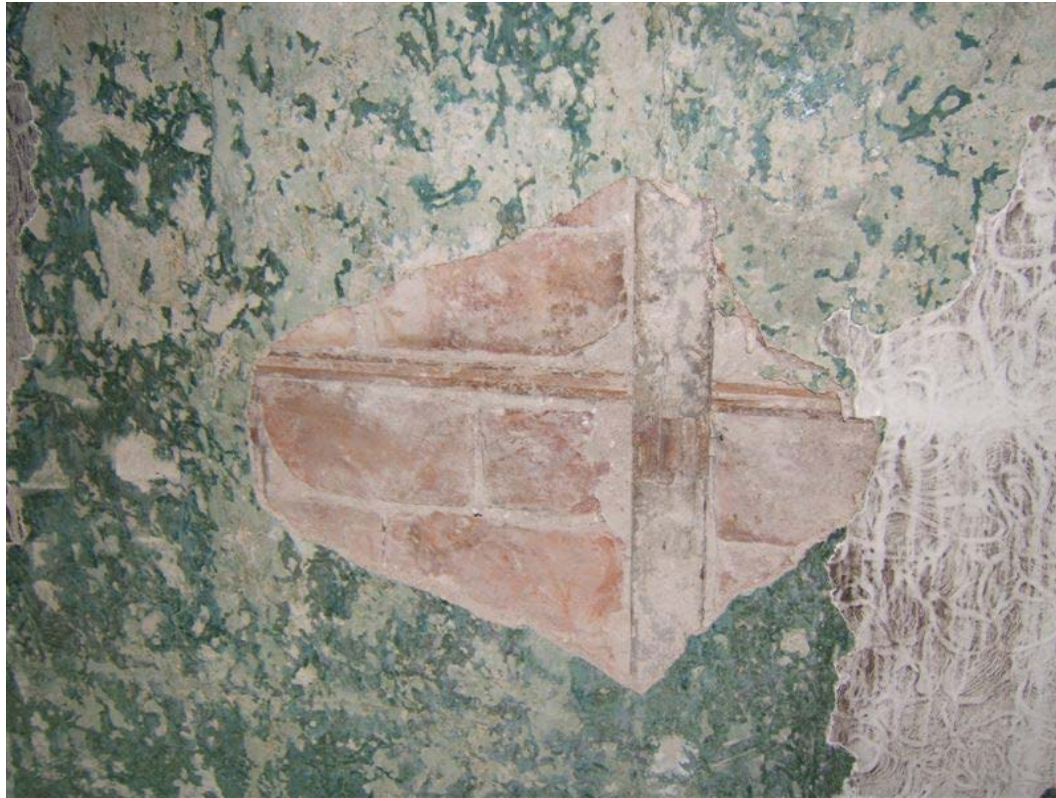
An example of the rather makeshift construction methods employed in the past. The partition wall between the fore-house and the old steps up to the first floor was a timber frame with brick infill. The bricks were laid on edge, to give maximum area with minimum number of bricks.
